NESHAP ASBESTOS SURVEY

VILLAGE OF WAUCONDA

*100 N. Main Street
Wauconda, IL 60084*

MEC Project #: 23-08-546-INSP

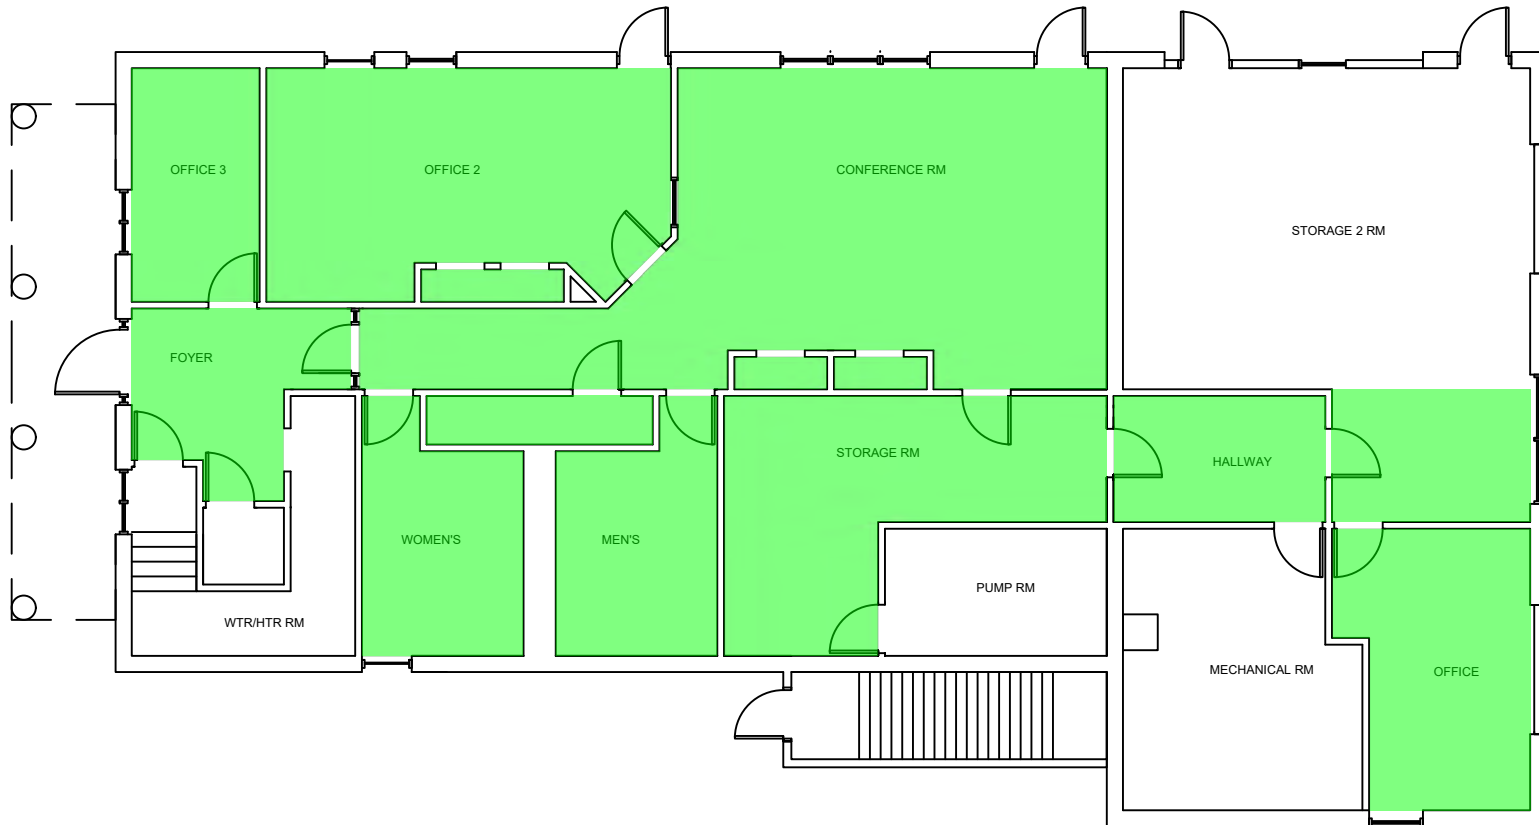
1ST FLOOR

HOMOGENEOUS AREA: MCA
DESCRIPTION: 2 x 4 Ceiling Tile - Pinholes & Fissures
QUANTITY ESTIMATE: 4,176 S.F.
ACM Y/N: No
COMMENTS: N/A

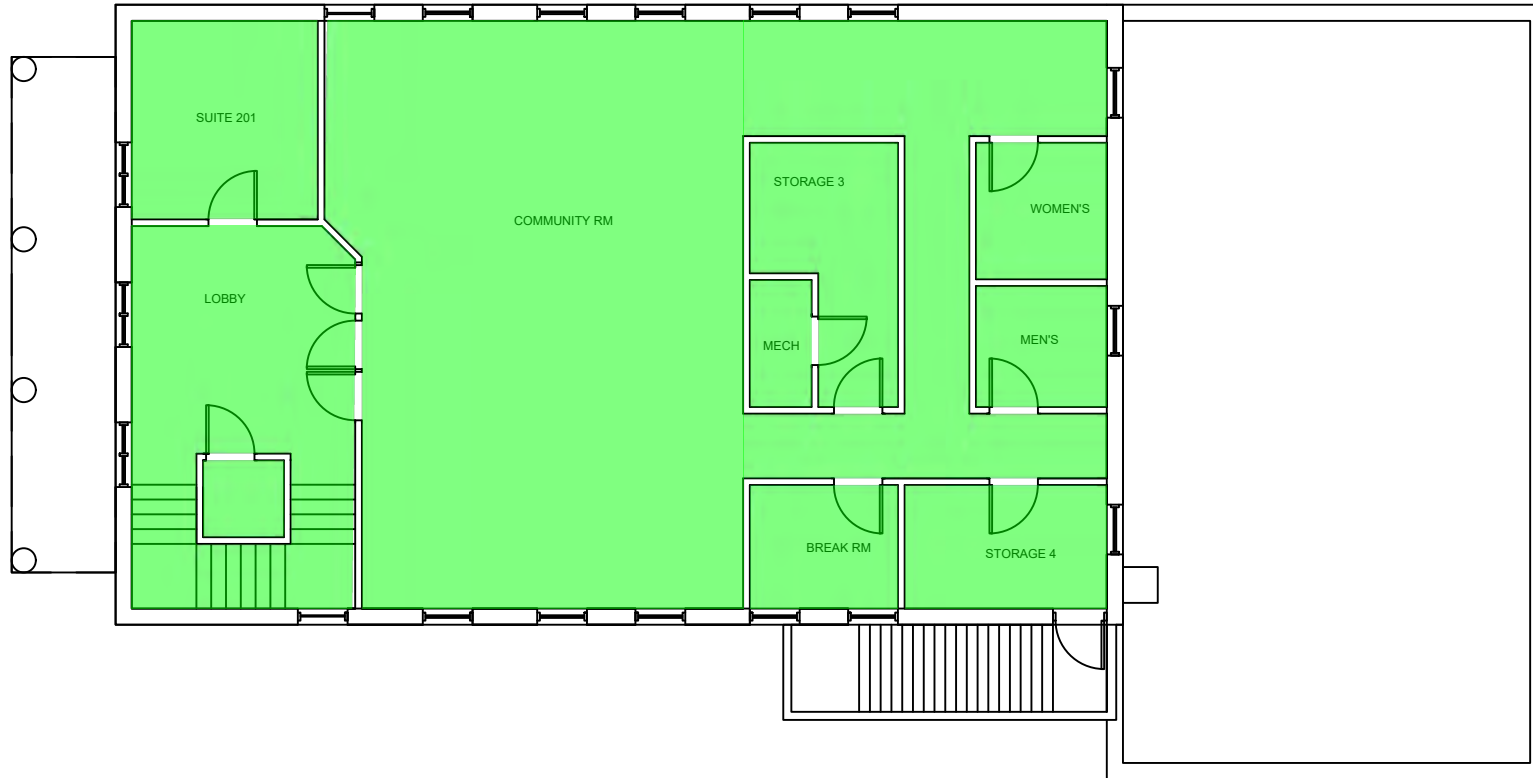
2ND FLOOR

HOMOGENEOUS AREA: MCA
DESCRIPTION: 2 x 4 Ceiling Tile - Pinholes & Fissures
QUANTITY ESTIMATE: 4,176 S.F.
ACM Y/N: No
COMMENTS: N/A

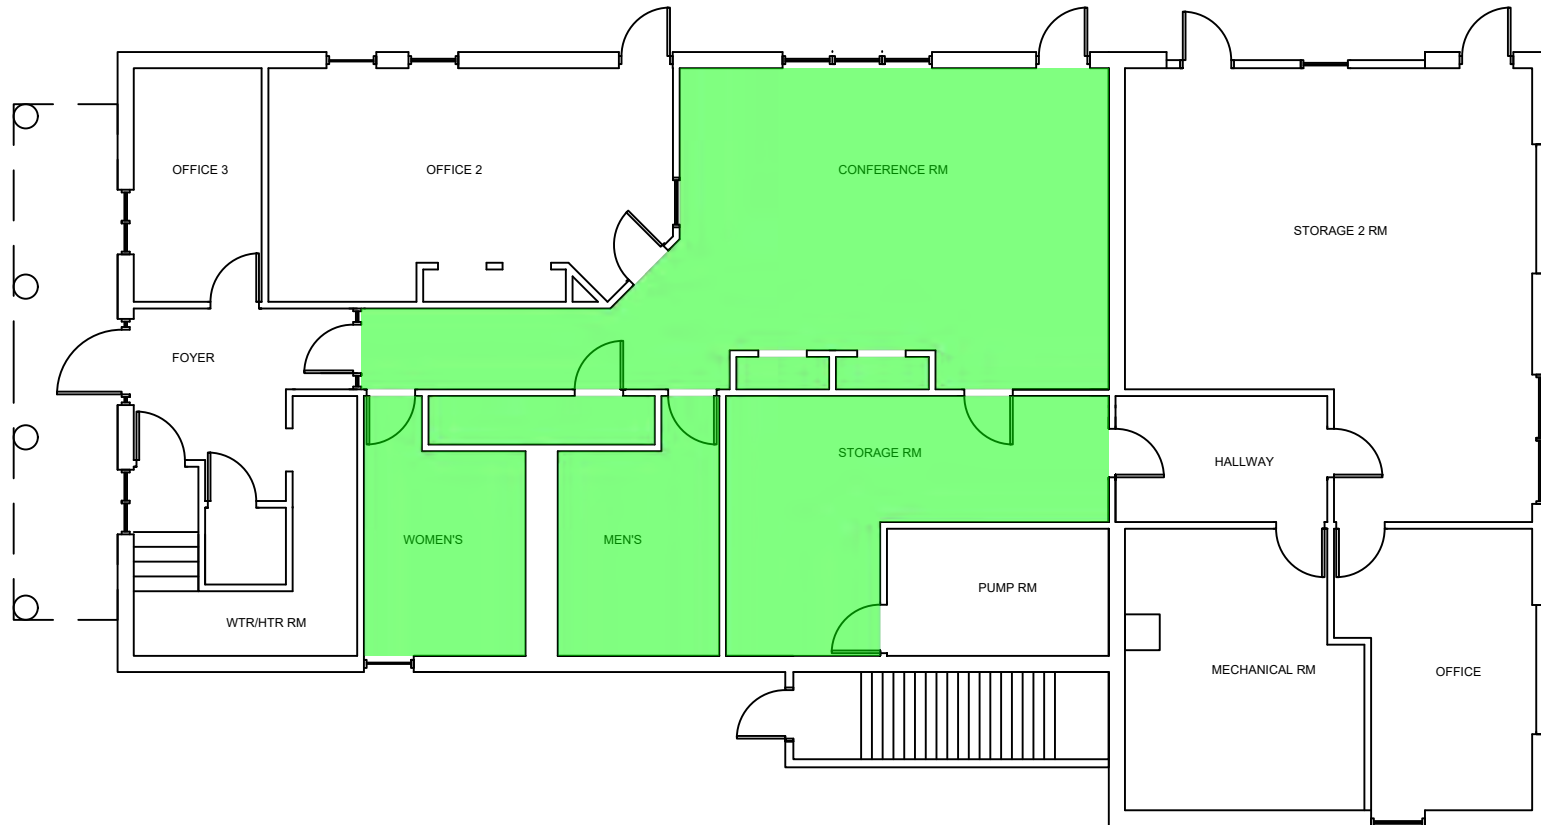
1ST FLOOR

HOMOGENEOUS AREA: MCB
DESCRIPTION: 2 x 4 Ceiling Tile - Smooth
QUANTITY ESTIMATE: 4,176 S.F.
ACM Y/N: No
COMMENTS: N/A

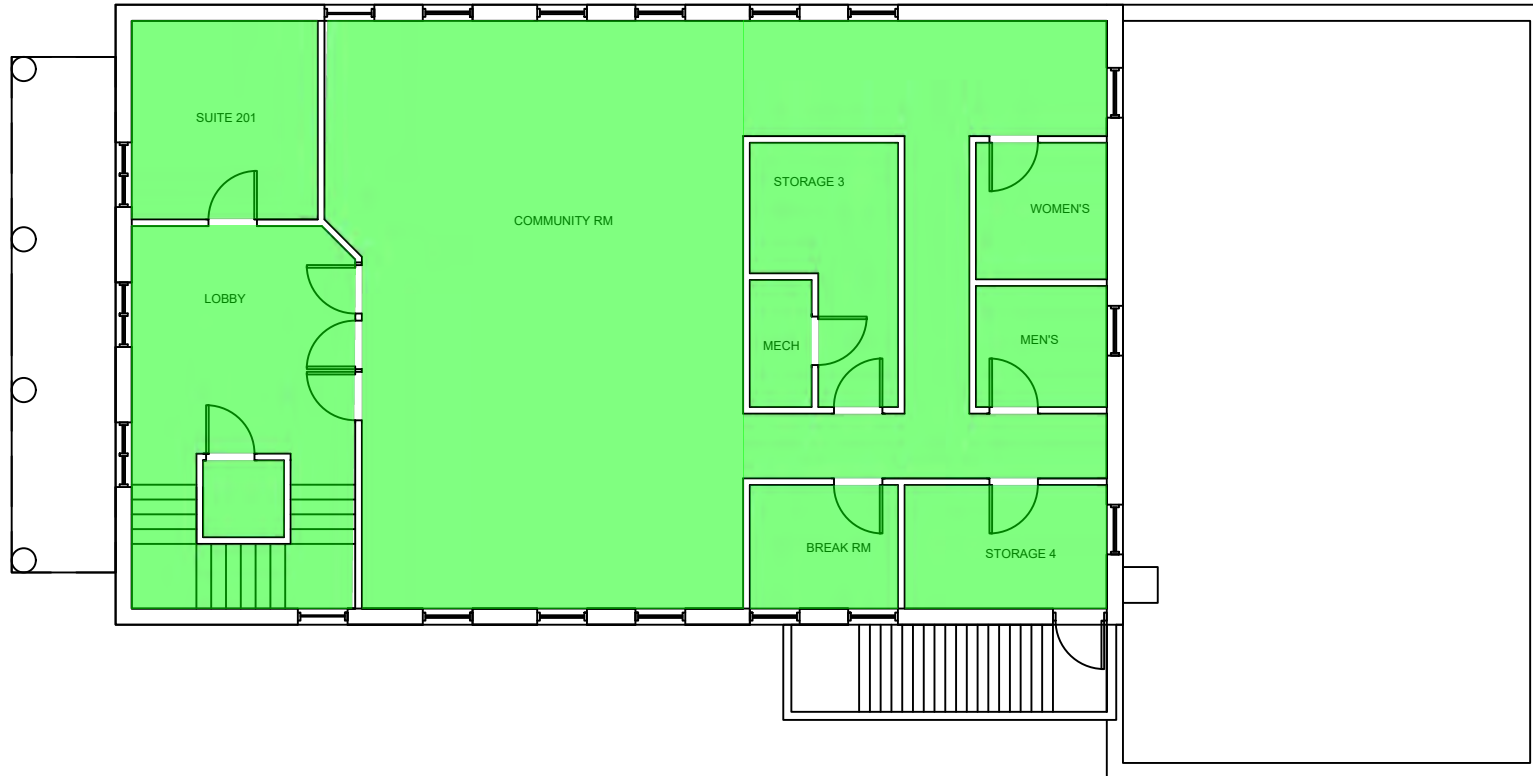
2ND FLOOR

HOMOGENEOUS AREA: MCB
DESCRIPTION: 2 x 4 Ceiling Tile - Smooth
QUANTITY ESTIMATE: 4,176 S.F.
ACM Y/N: No
COMMENTS: N/A

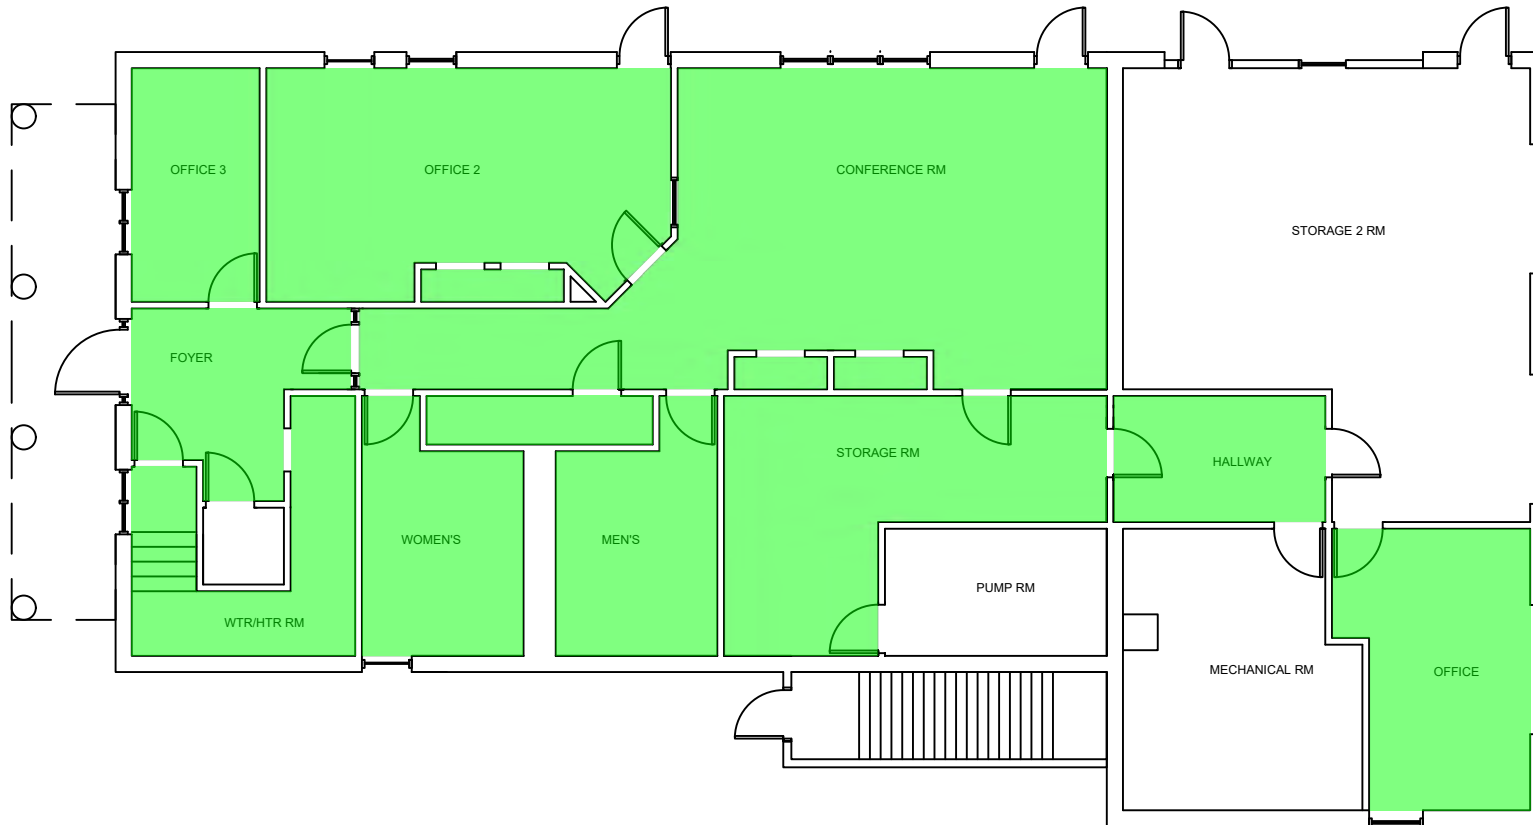
1ST FLOOR

HOMOGENEOUS AREA: MBA
DESCRIPTION: Vinyl Baseboard - Beige
QUANTITY ESTIMATE: 1,032 L.F.
ACM Y/N: No
COMMENTS: N/A

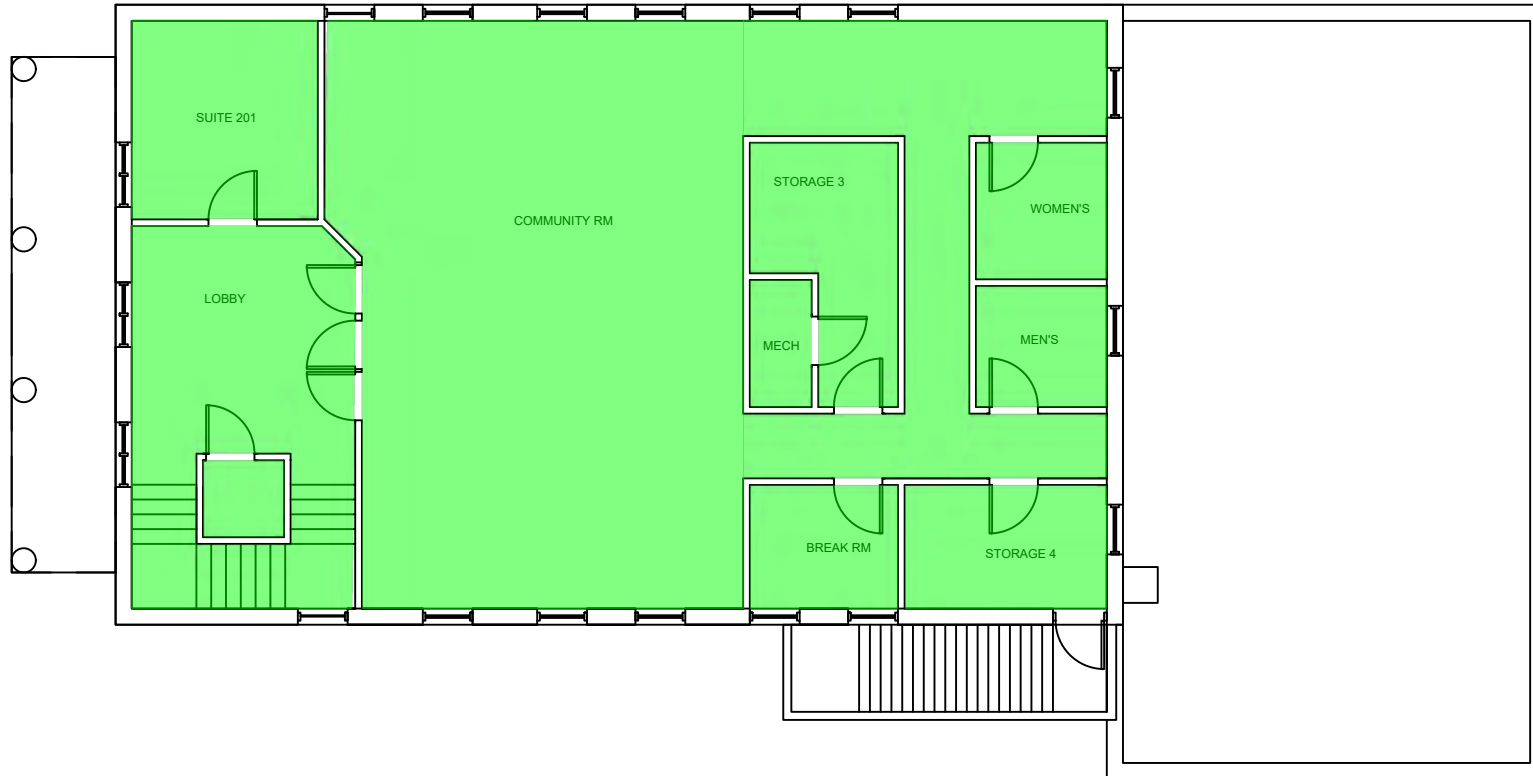
2ND FLOOR

HOMOGENEOUS AREA: MBA
DESCRIPTION: Vinyl Baseboard - Beige
QUANTITY ESTIMATE: 1,032 L.F.
ACM Y/N: No
COMMENTS: N/A

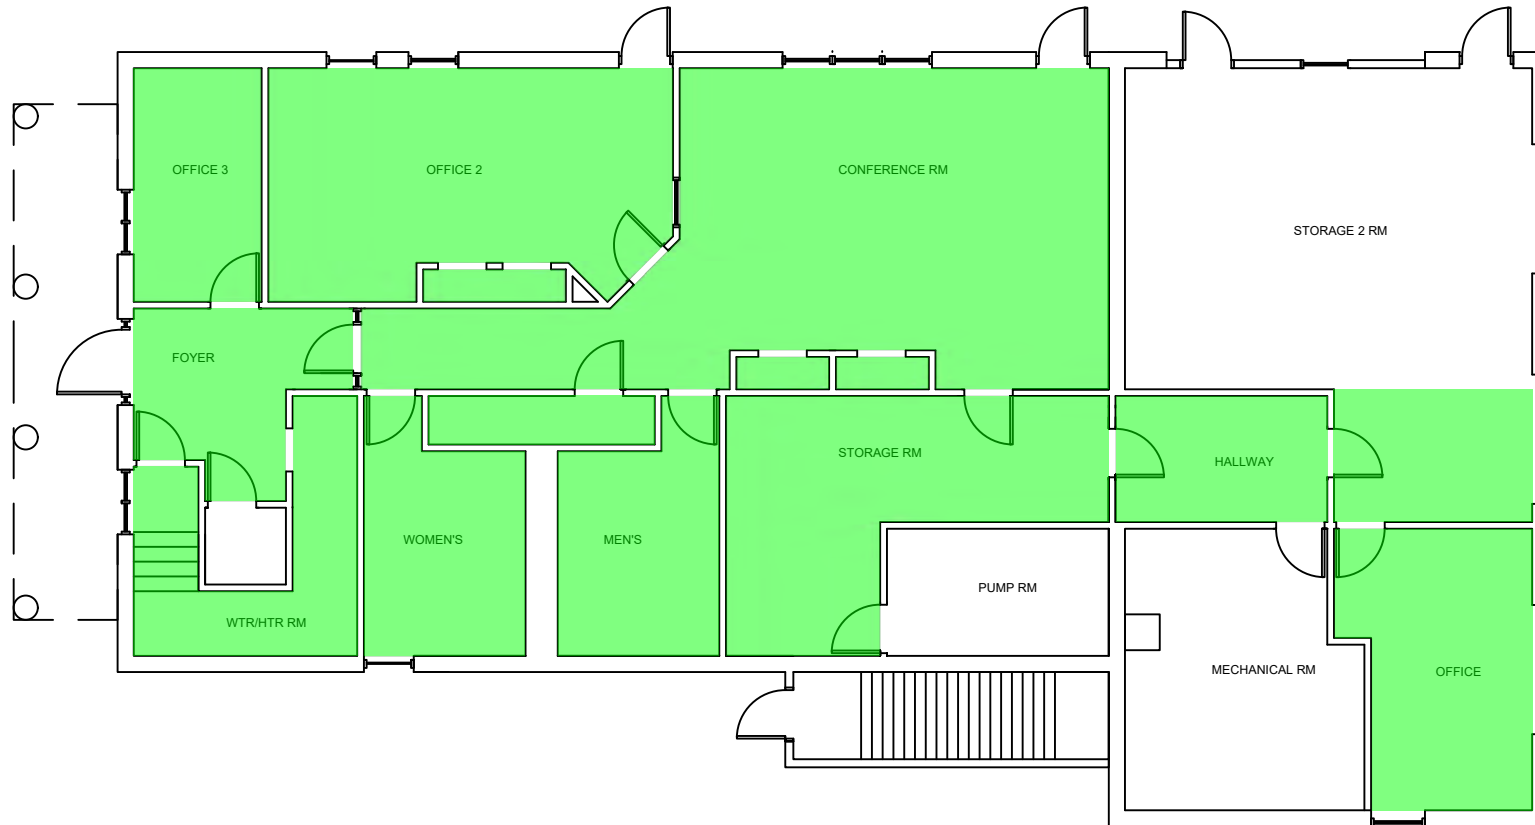
1ST FLOOR

HOMOGENEOUS AREA: MDA
DESCRIPTION: Drywall/Tape/Compound
QUANTITY ESTIMATE: 9,396 S.F.
ACM Y/N: No
COMMENTS: N/A

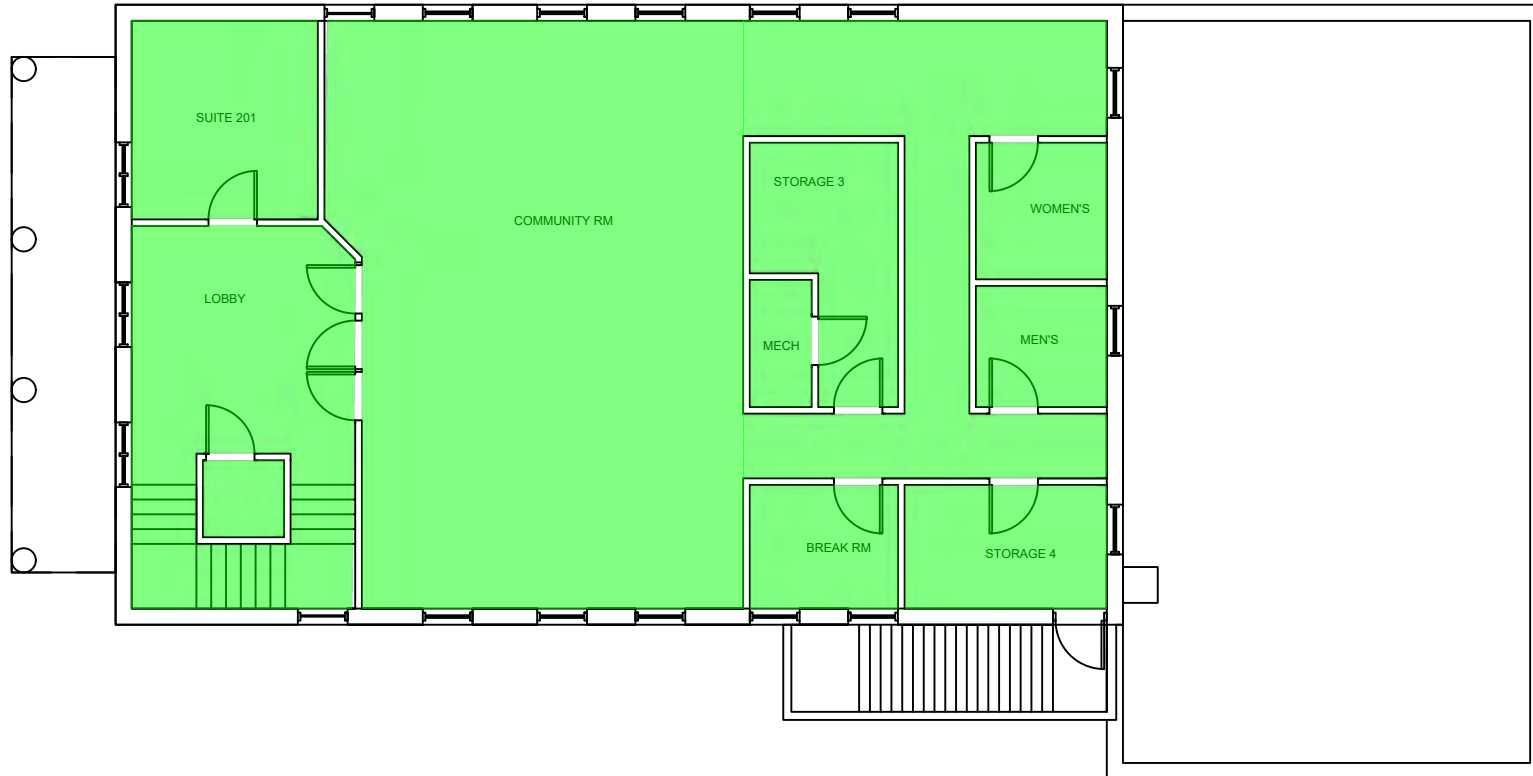
2ND FLOOR

HOMOGENEOUS AREA: MDA
DESCRIPTION: Drywall/Tape/Compound
QUANTITY ESTIMATE: 9,396 S.F.
ACM Y/N: No
COMMENTS: N/A

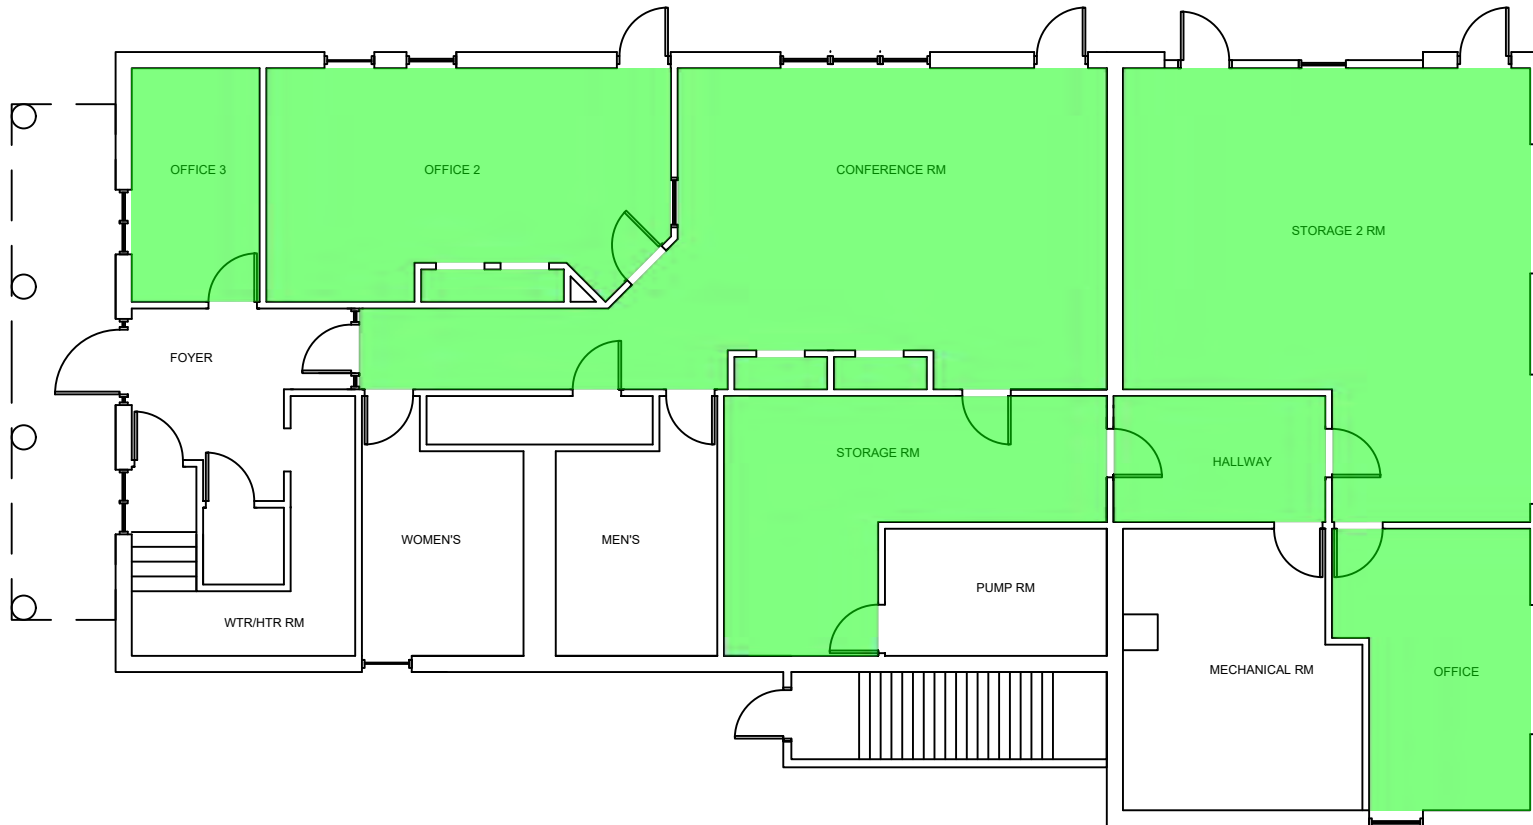
1ST FLOOR

HOMOGENEOUS AREA: MMA
DESCRIPTION: Carpet Glue - Yellow
QUANTITY ESTIMATE: 2,392 S.F.
ACM Y/N: No
COMMENTS: N/A

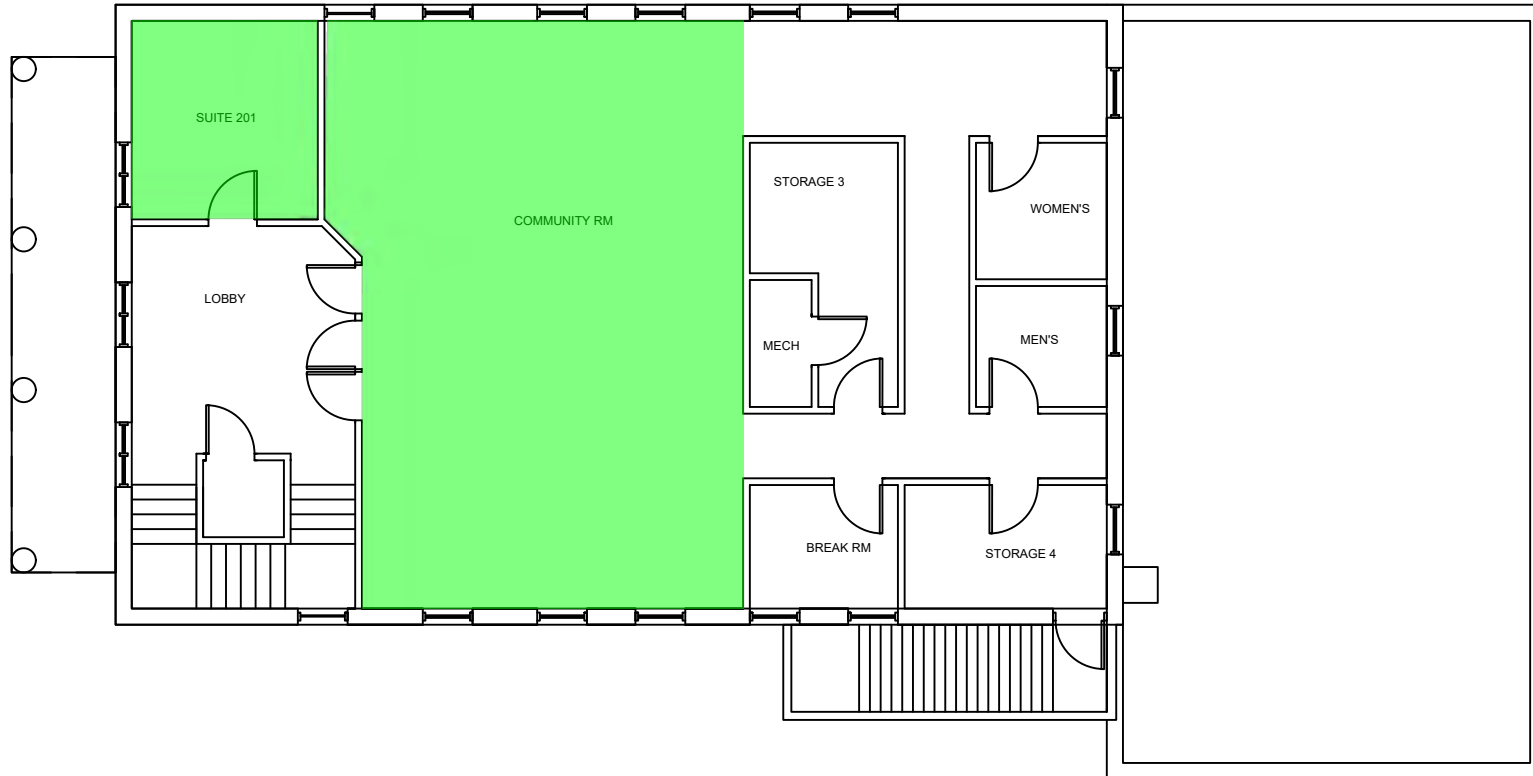
2ND FLOOR

HOMOGENEOUS AREA: MMA
DESCRIPTION: Carpet Glue - Yellow
QUANTITY ESTIMATE: 2,392 S.F.
ACM Y/N: No
COMMENTS: N/A

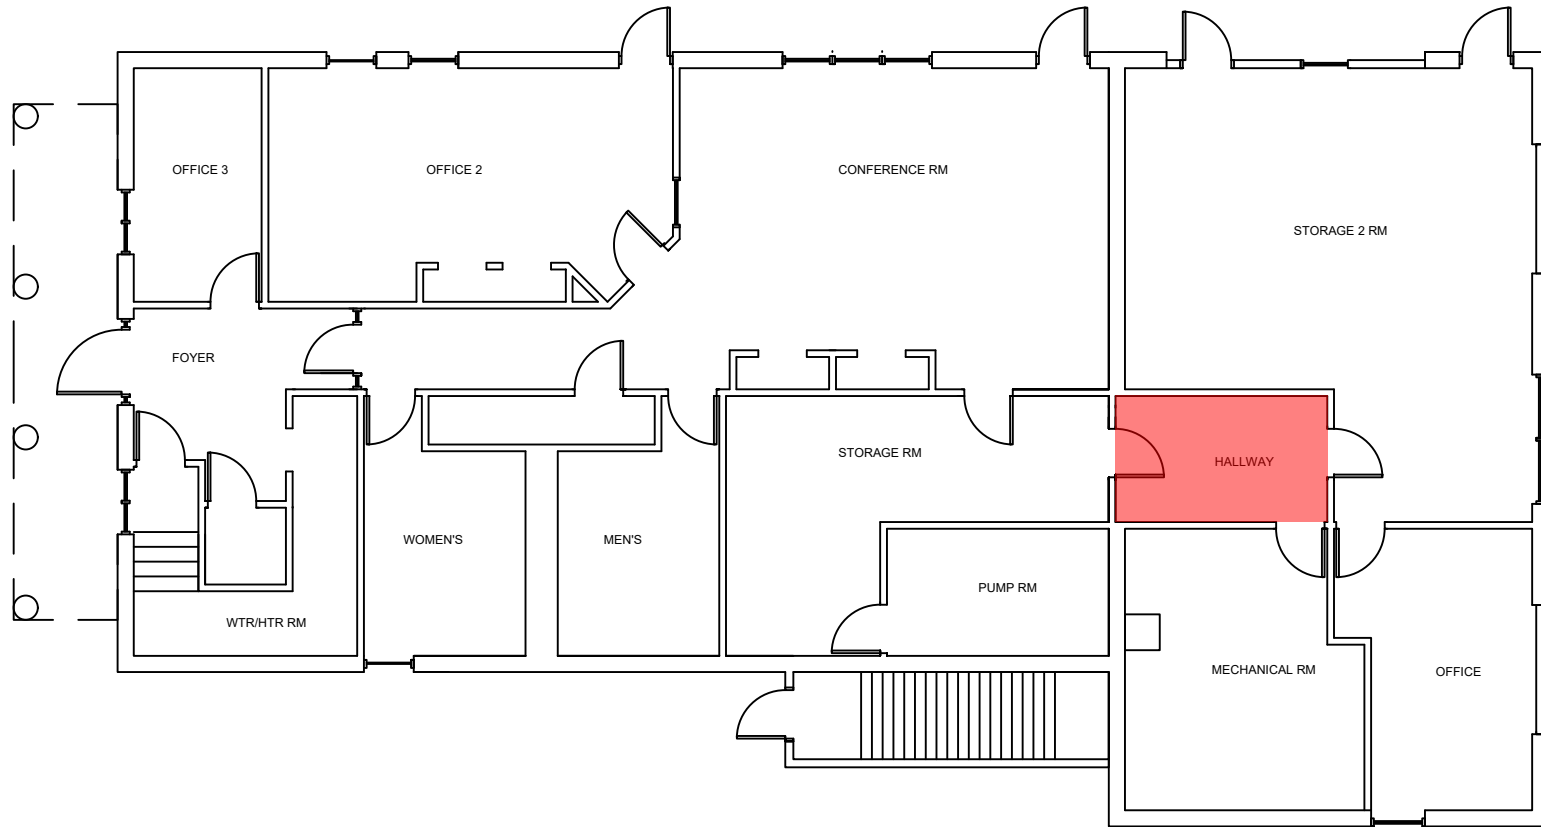
1ST FLOOR

HOMOGENEOUS AREA: MFA
DESCRIPTION: 12 x 12 Floor Tile/Mastic - Beige
QUANTITY ESTIMATE: 60 S.F.
ACM Y/N: Yes
COMMENTS: N/A

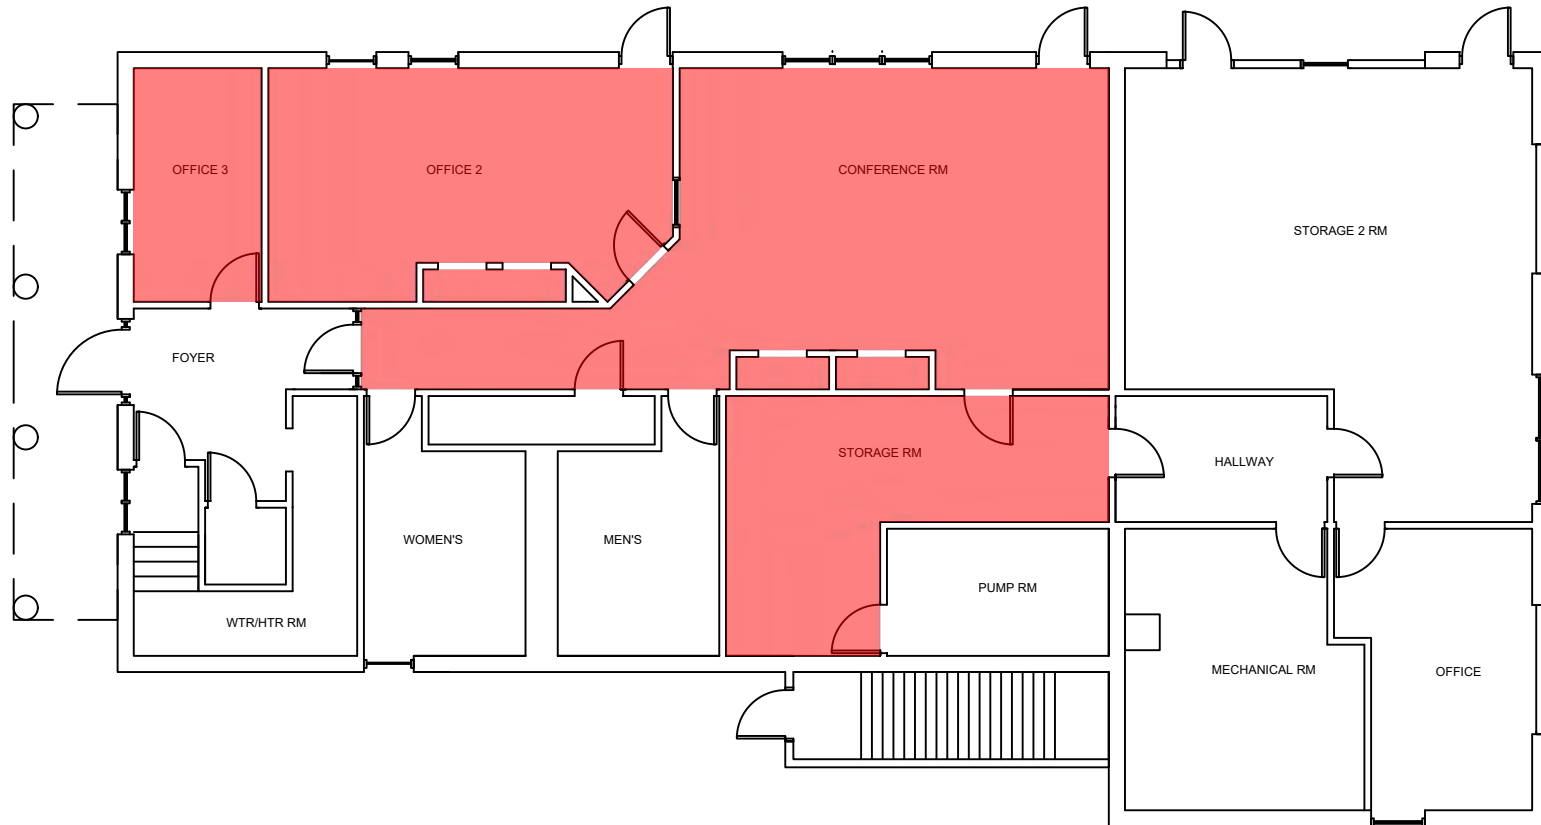
1ST FLOOR

HOMOGENEOUS AREA: MMB
DESCRIPTION: Residual Mastic - Black
QUANTITY ESTIMATE: 1,108 S.F.
ACM Y/N: Yes
COMMENTS: N/A

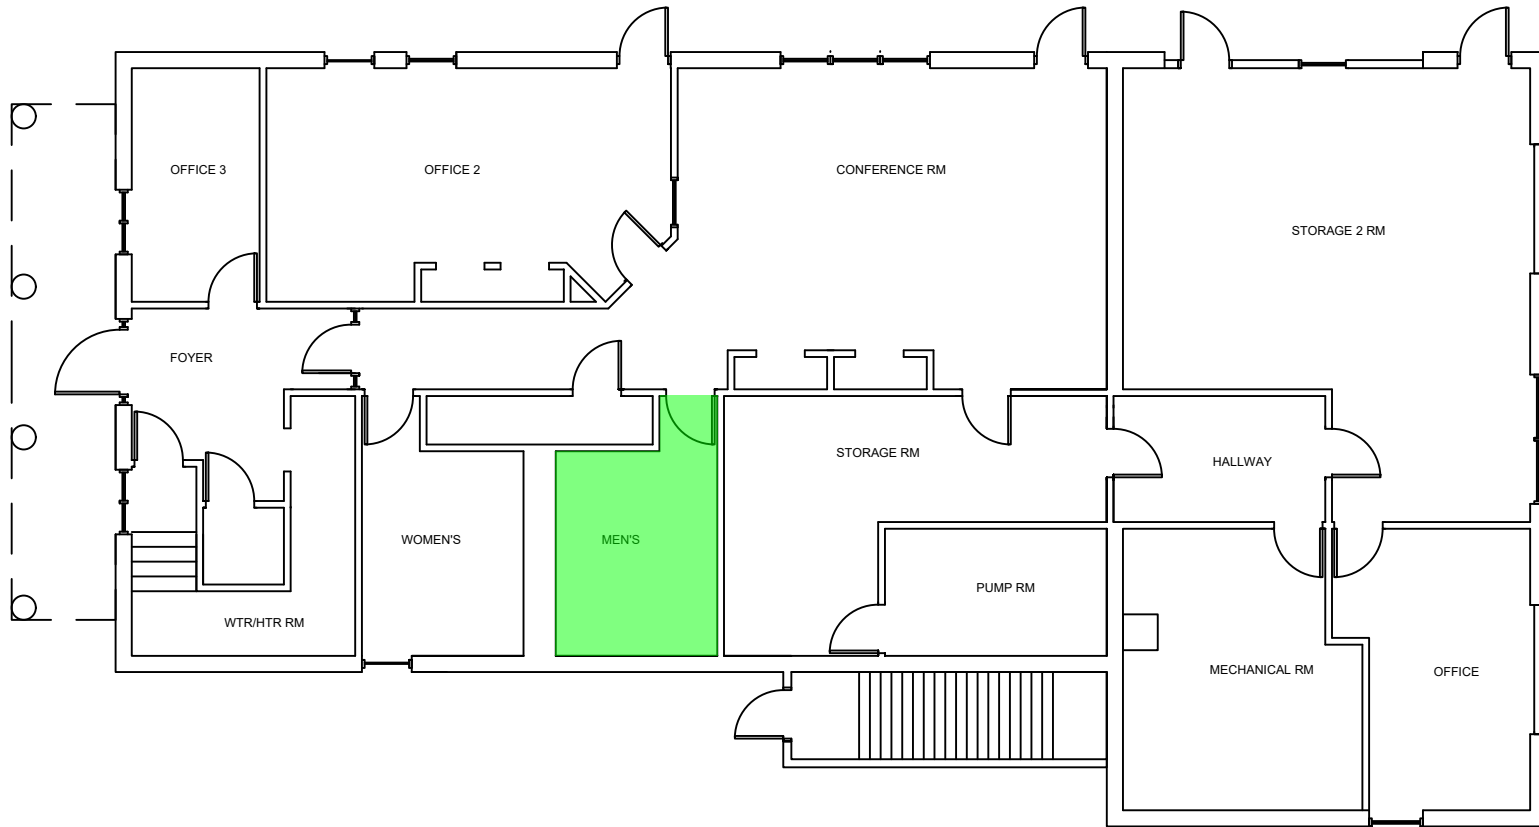
1ST FLOOR

HOMOGENEOUS AREA: MFB
DESCRIPTION: 12 x 12 Floor Tile/Mastic - Beige w/Brown Specks
QUANTITY ESTIMATE: 168 S.F.
ACM Y/N: No
COMMENTS: N/A

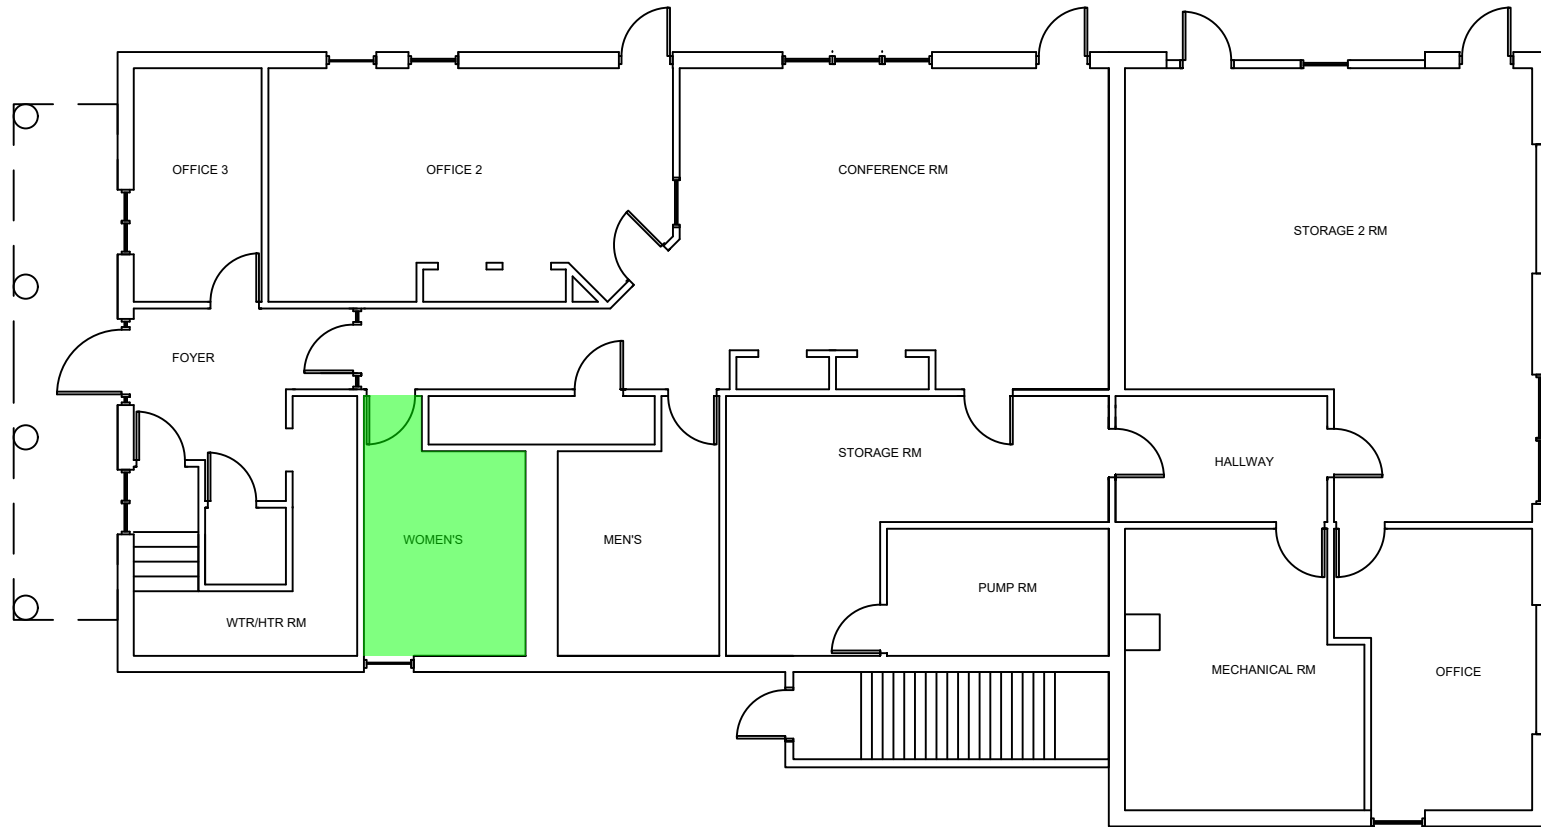
1ST FLOOR

HOMOGENEOUS AREA: MFC
DESCRIPTION: 12 x 12 Floor Tile/Mastic - Gray w/Reddish Streaks
QUANTITY ESTIMATE: 156 S.F.
ACM Y/N: No
COMMENTS: N/A

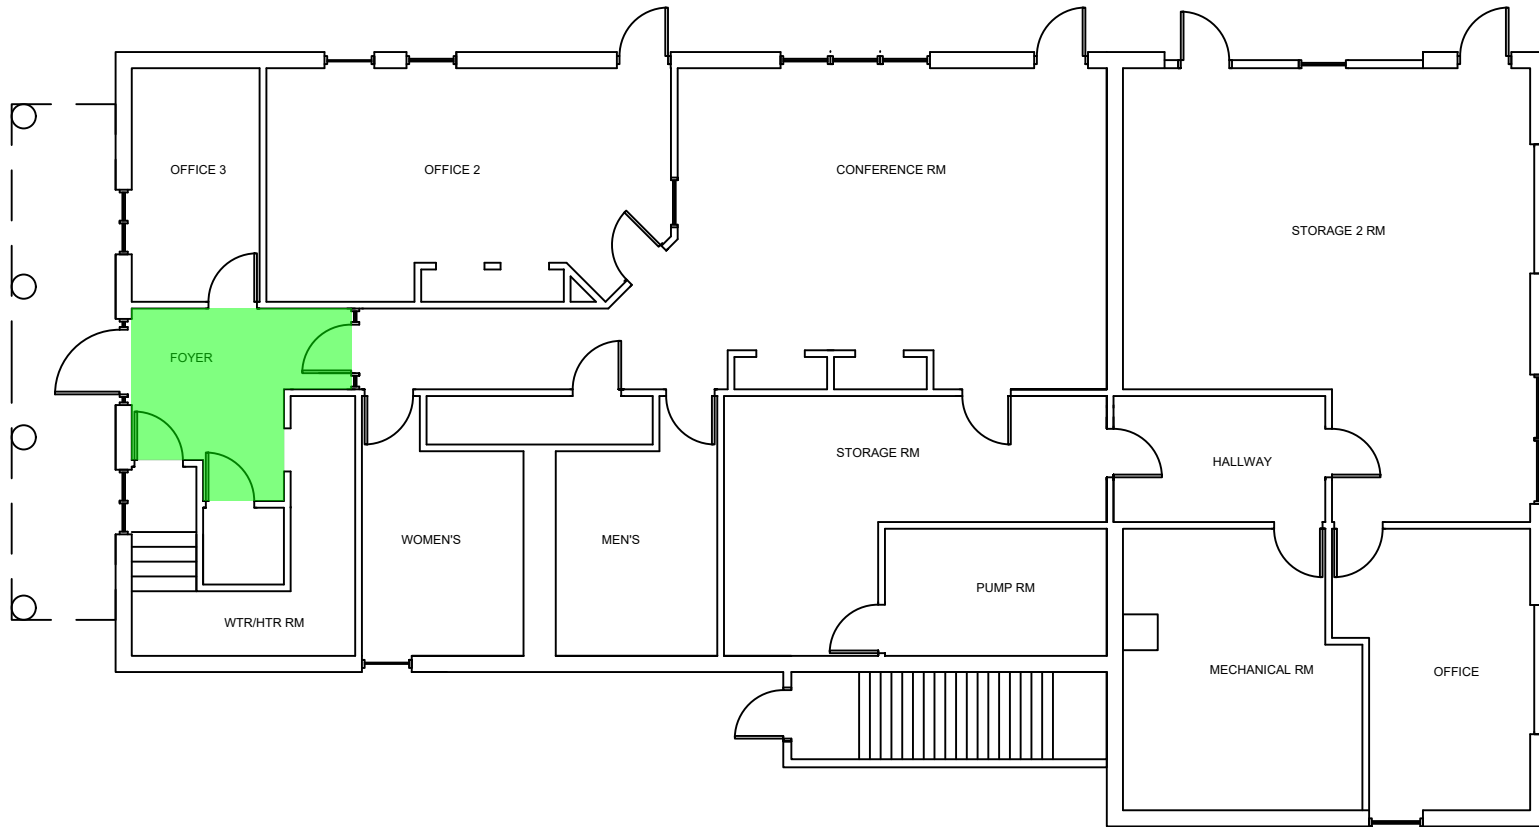
1ST FLOOR

HOMOGENEOUS AREA: MFD
DESCRIPTION: 12 x 12 Floor Tile/Mastic - Pinkish Color w/White Streaks
QUANTITY ESTIMATE: 690 S.F.
ACM Y/N: No
COMMENTS: N/A

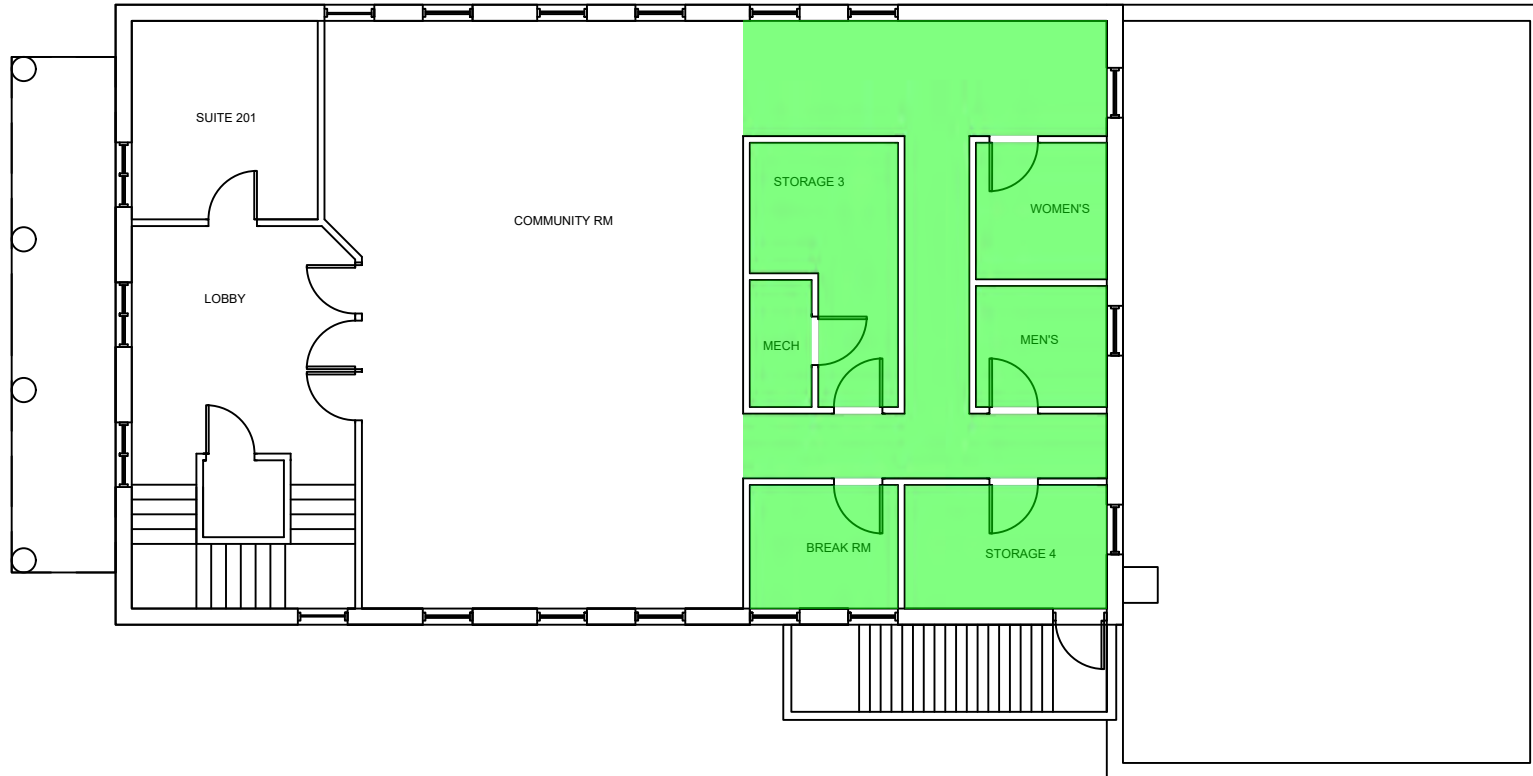
2ND FLOOR

HOMOGENEOUS AREA: MFD
DESCRIPTION: 12 x 12 Floor Tile/Mastic - Pinkish Color w/White Streaks
QUANTITY ESTIMATE: 690 S.F.
ACM Y/N: No
COMMENTS: N/A

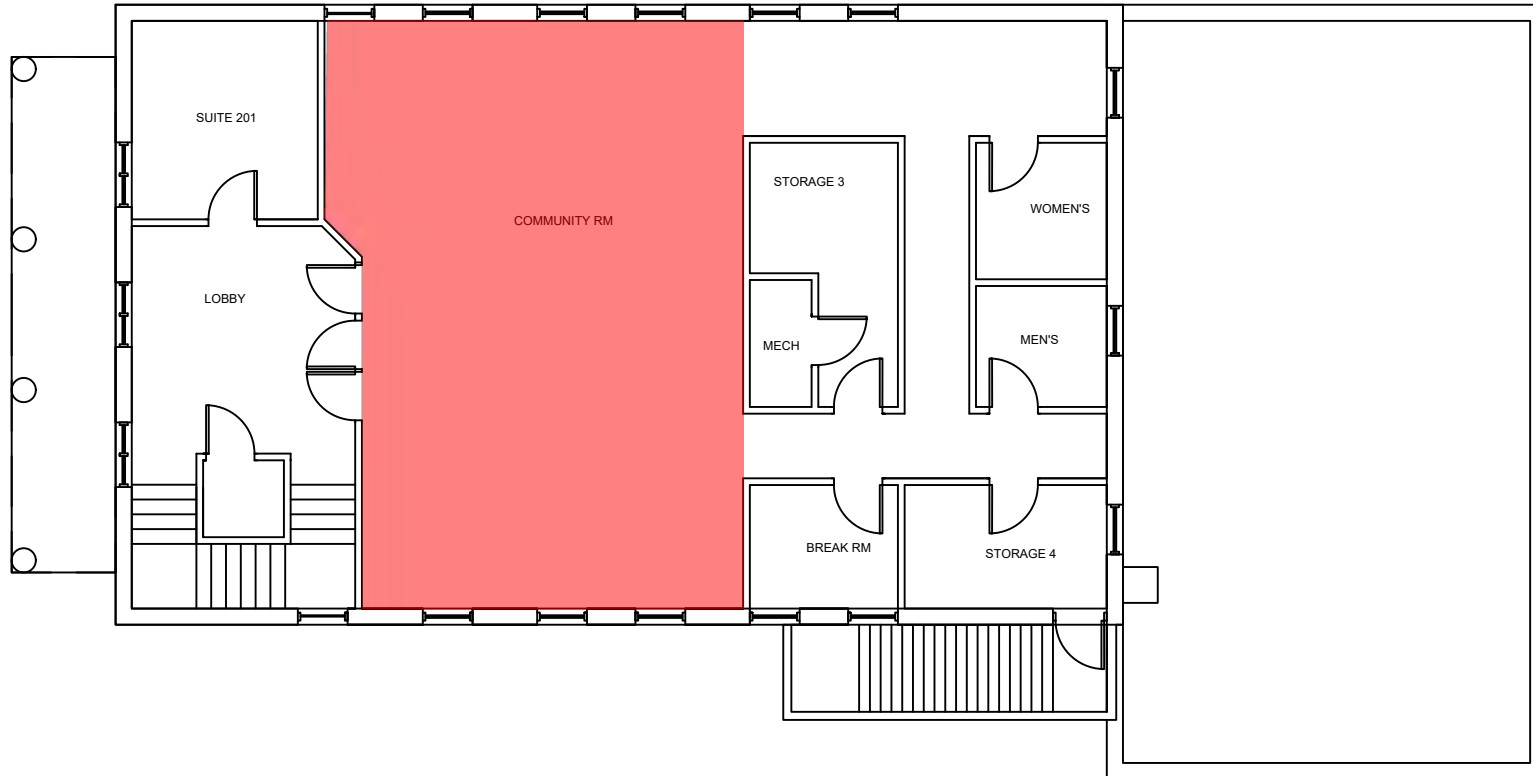
2ND FLOOR

HOMOGENEOUS AREA: MFE
DESCRIPTION: 12 x 12 Floor Tile/Mastic - Brown
QUANTITY ESTIMATE: 952 S.F.
ACM Y/N: Yes
COMMENTS: N/A

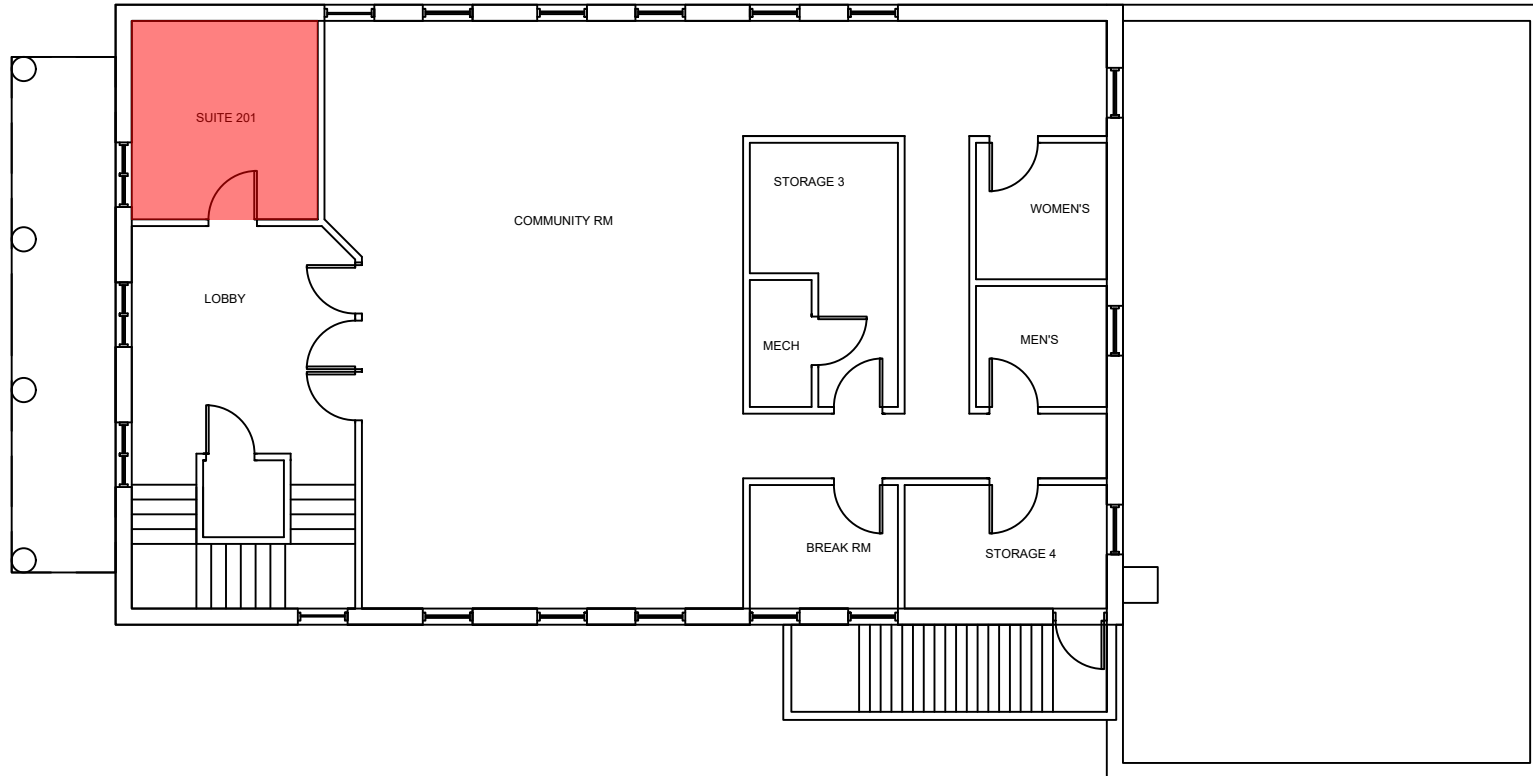
2ND FLOOR

HOMOGENEOUS AREA: MFF
DESCRIPTION: 12 x 12 Floor Tile/Mastic - White w/Black Steaks
QUANTITY ESTIMATE: 90 S.F.
ACM Y/N: Yes
COMMENTS: N/A
