NESHAP ASBESTOS SURVEY

VILLAGE OF WAUCONDA

*100 N. Main Street
Wauconda, IL 60084*

MEC Project #: 23-08-546-INSP

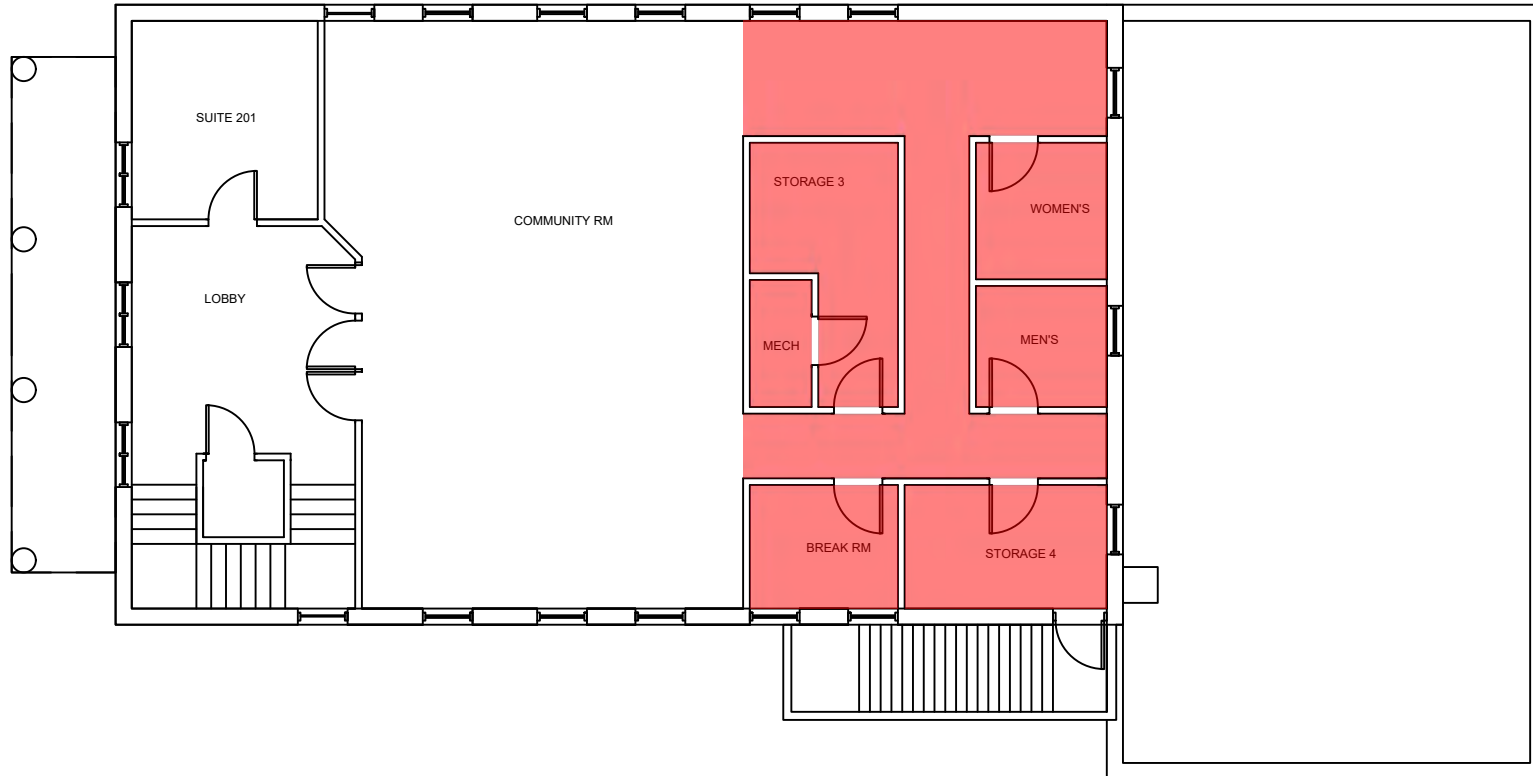
2ND FLOOR

HOMOGENEOUS AREA: MFG
DESCRIPTION: 12 x 12 Floor Tile/Mastic - Gray w/White Streaks
QUANTITY ESTIMATE: 510 S.F.
ACM Y/N: Yes
COMMENTS: N/A

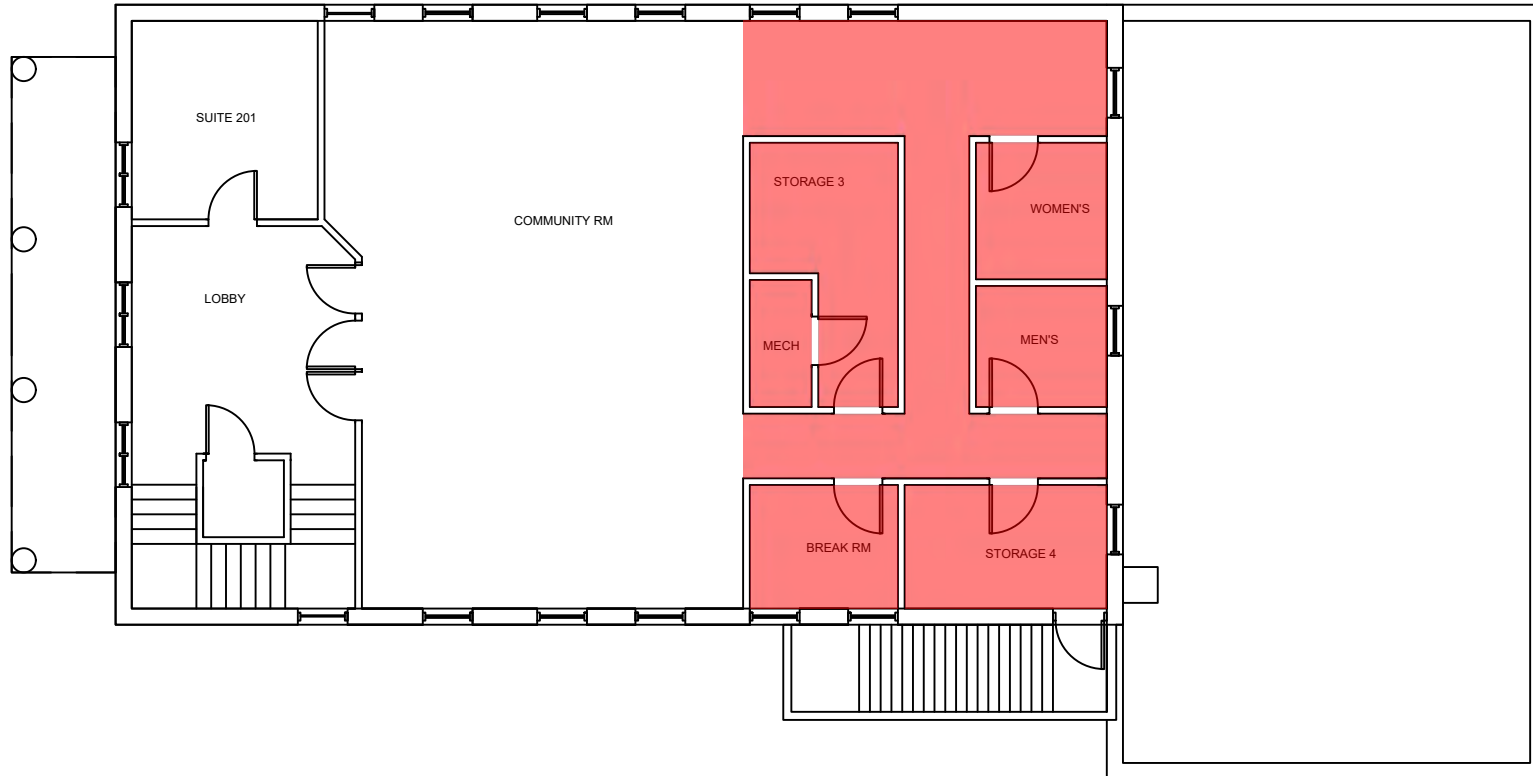
2ND FLOOR

HOMOGENEOUS AREA: MFH
DESCRIPTION: Fiberboard Floor/Mastic
QUANTITY ESTIMATE: 510 S.F.
ACM Y/N: Yes
COMMENTS: N/A

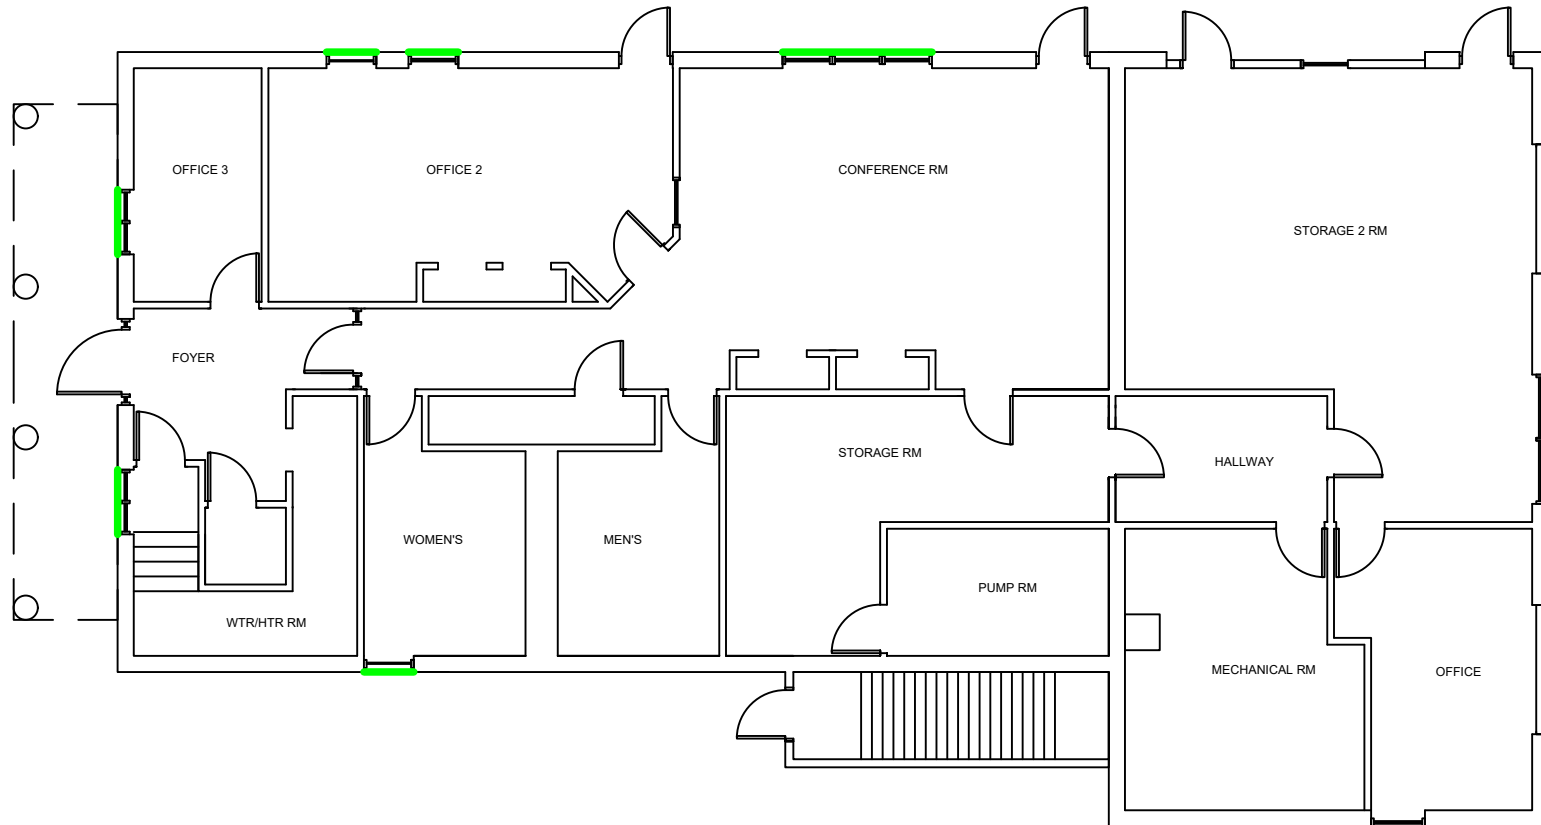
1ST FLOOR

HOMOGENEOUS AREA: MMC
DESCRIPTION: Exterior Window Caulk
QUANTITY ESTIMATE: 22 Windows
ACM Y/N: No
COMMENTS: N/A

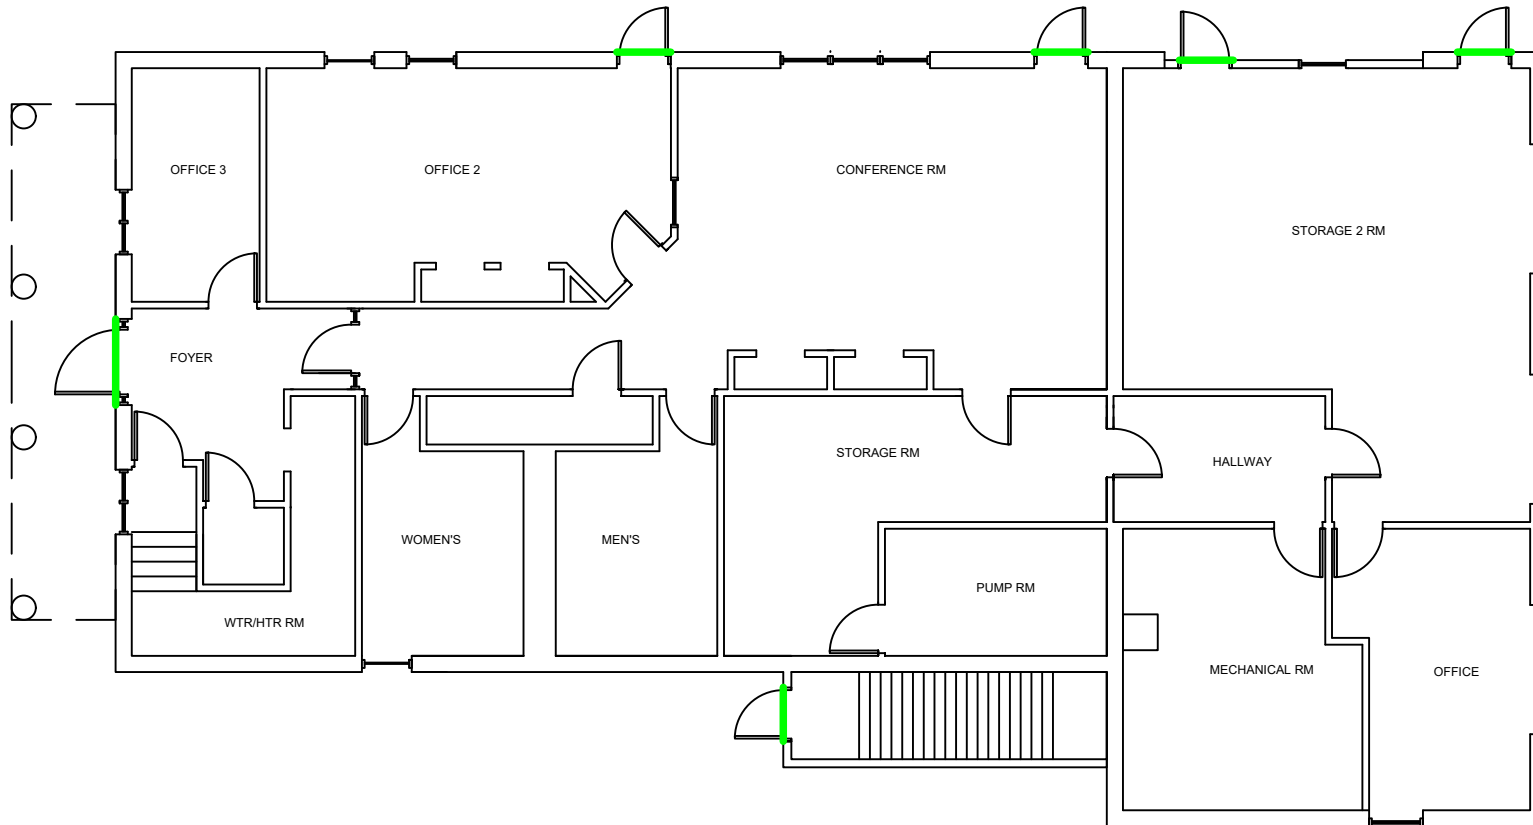
1ST FLOOR

HOMOGENEOUS AREA: MMD
DESCRIPTION: Exterior Door Caulk
QUANTITY ESTIMATE: 6 Doors
ACM Y/N: No
COMMENTS: N/A

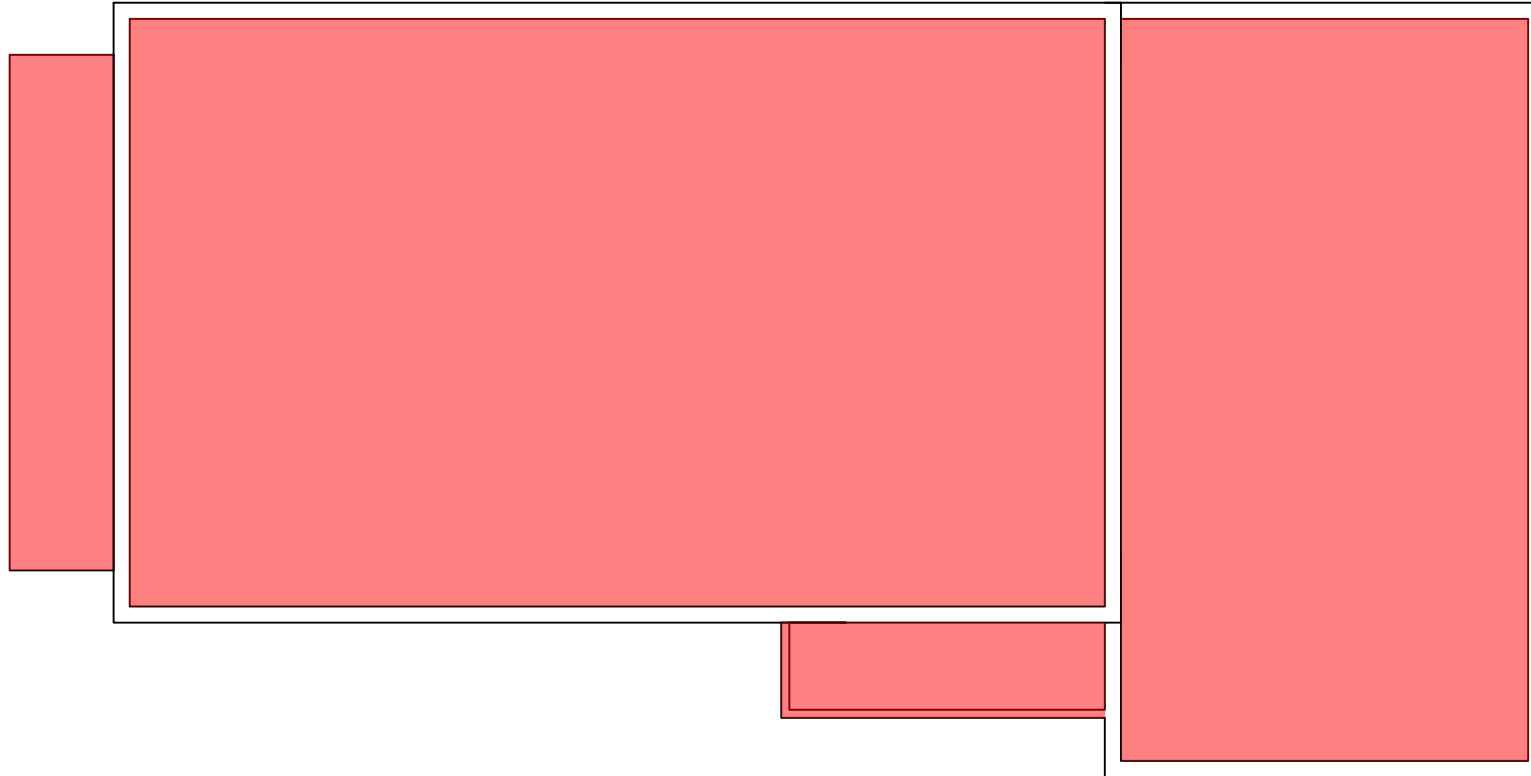
1ST FLOOR

HOMOGENEOUS AREA: MRA
DESCRIPTION: Flat Roof Membrane
QUANTITY ESTIMATE: 2,008 S.F.
ACM Y/N: Assumed
COMMENTS: N/A

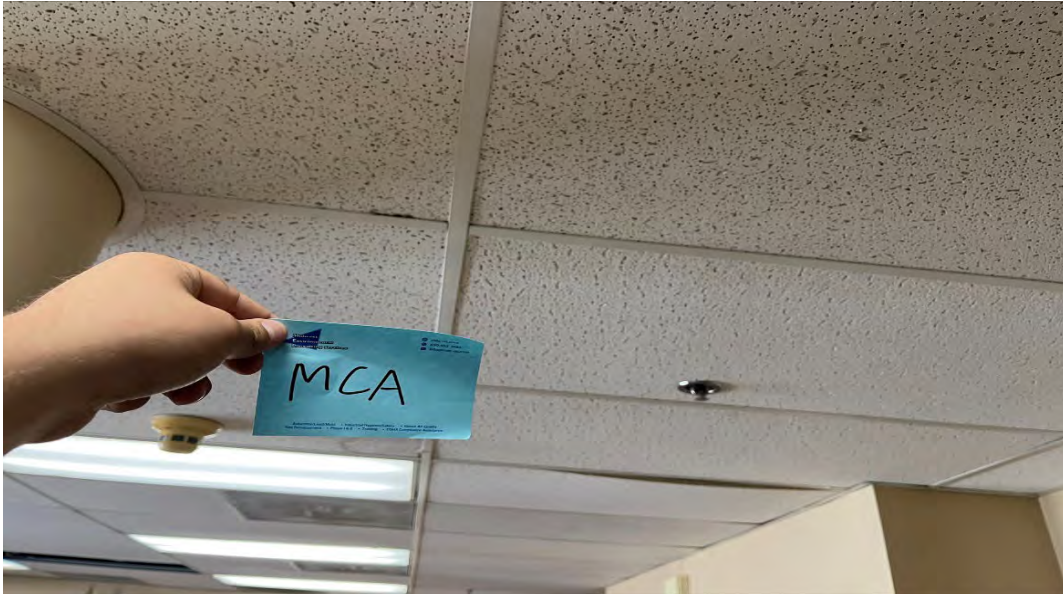
Homogeneous Area:	MCA
Material Description:	2x4 Ceiling Tile - Pinholes & Fissures
Material Location:	Throughout
ACM Y/N:	No

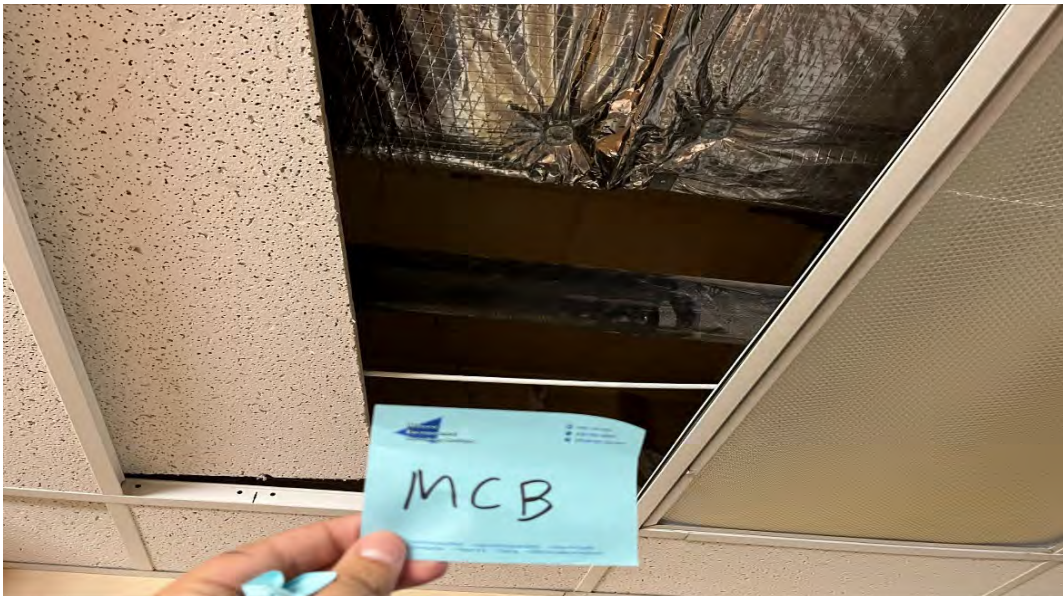
Homogeneous Area:	MCB
Material Description:	12x12 Ceiling Tile - Smooth White
Material Location:	Above MCA
ACM Y/N:	No

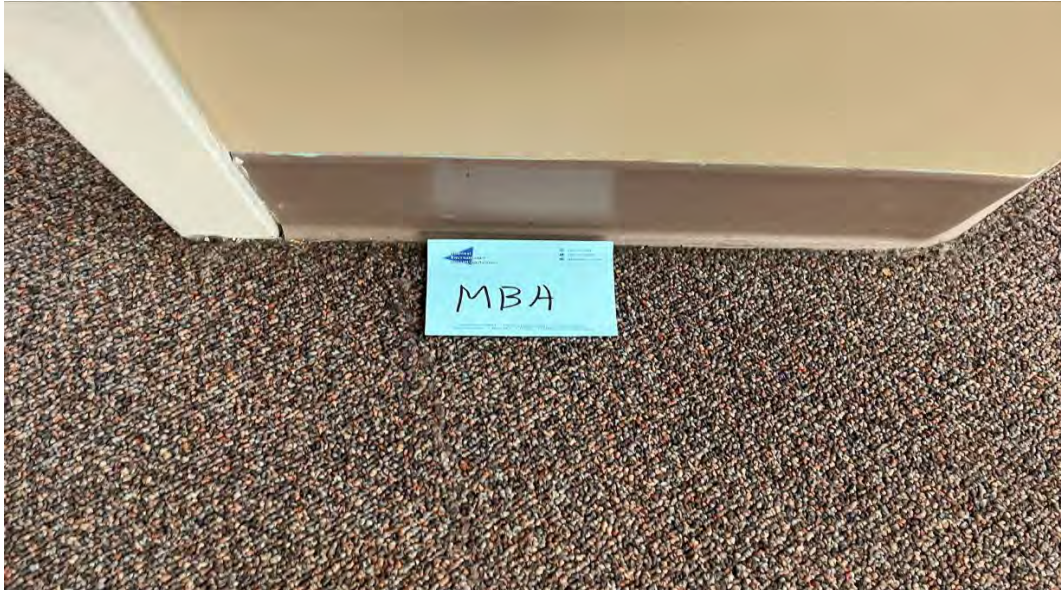
Homogeneous Area:	MBA
Material Description:	Vinyl Baseboard - Beige
Material Location:	Throughout
ACM Y/N:	No

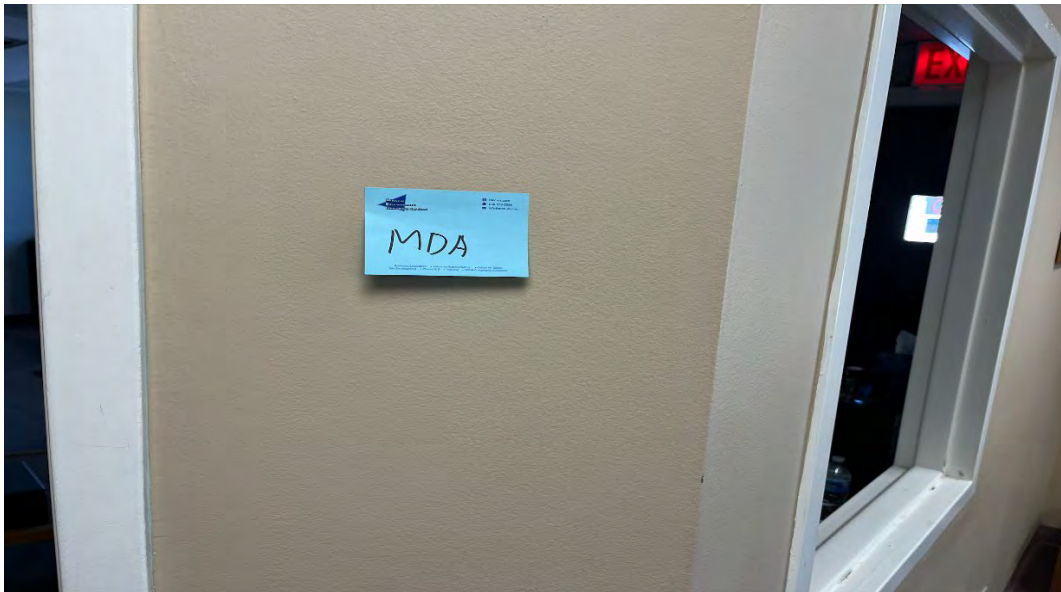
Homogeneous Area:	MDA
Material Description:	Drywall/Tape/Compound
Material Location:	Throughout
ACM Y/N:	No

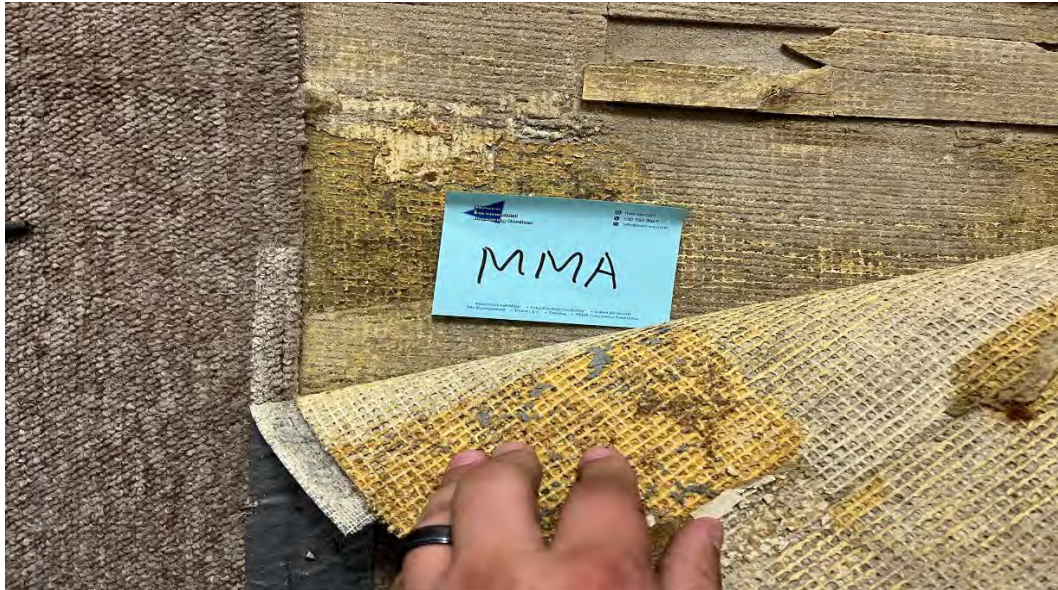
Homogeneous Area:	MMA
Material Description:	Carpet Glue - Yellow
Material Location:	Office, Hallway, Storage Room, Storage Room 2, Conference Room,
ACM Y/N:	No

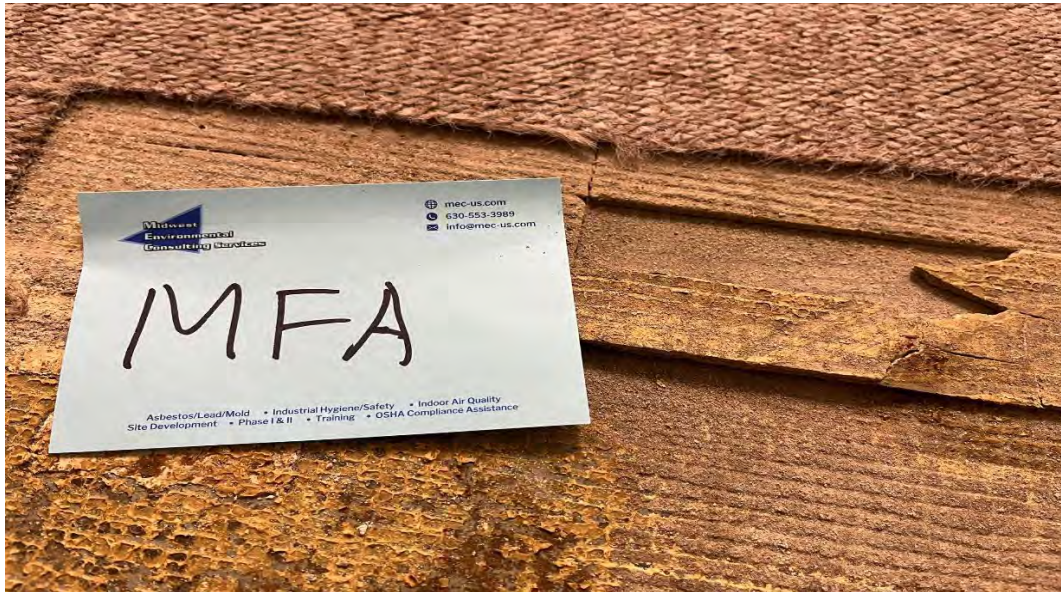
Homogeneous Area:	MFA
Material Description:	12x12 Floor Tile/Mastic - Beige
Material Location:	Under Carpet in Hallway
ACM Y/N:	Yes

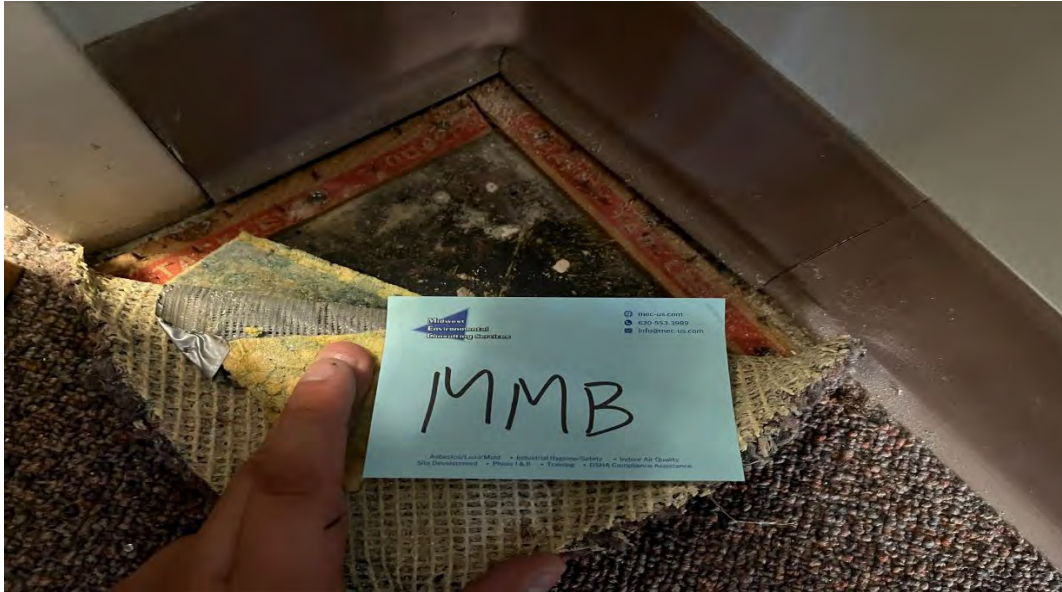
Homogeneous Area:	MMB
Material Description:	Residual Mastic - Black
Material Location:	Under Carpet in Storage Room, Conference Room, Office 2, and
ACM Y/N:	Yes

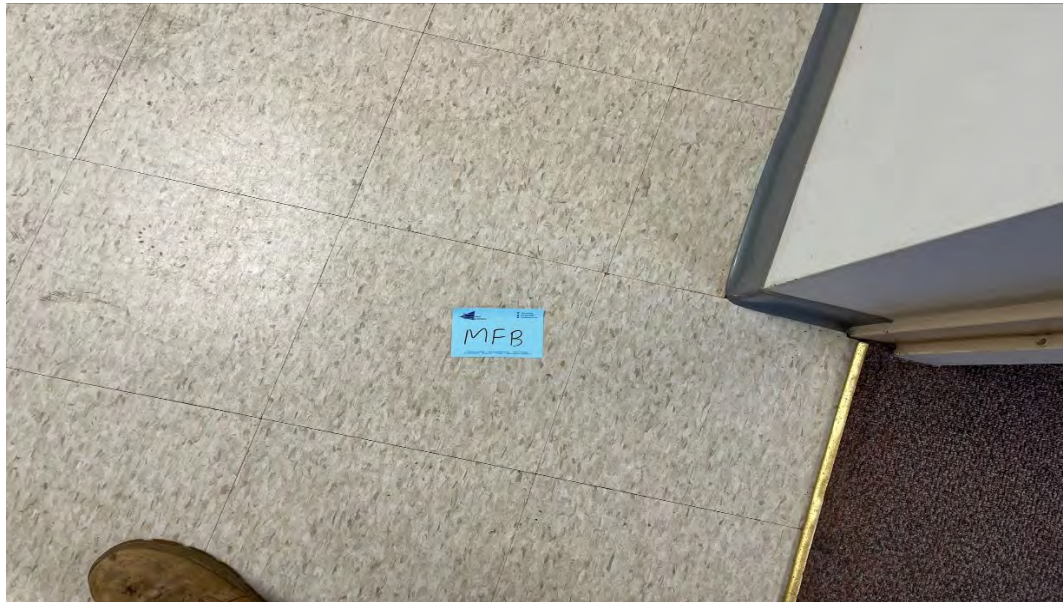
Homogeneous Area:	MFB
Material Description:	12x12 Floor Tile/Mastic - Beige w/ Brown Specks
Material Location:	Men's Bathroom
ACM Y/N:	No

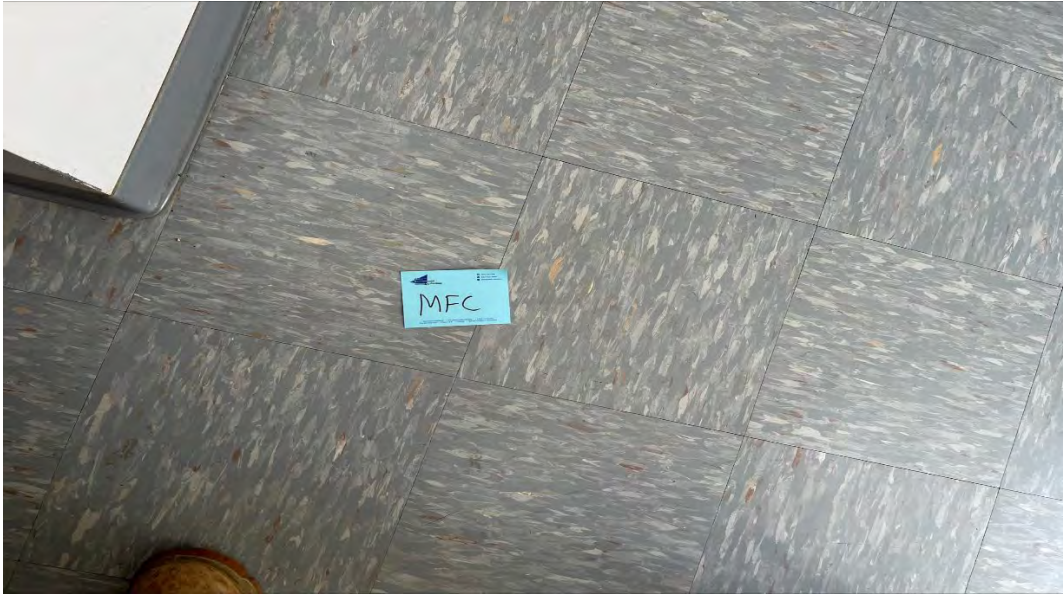
Homogeneous Area:	MFC
Material Description:	12x12 Floor Tile/Mastic - Gray w/ Reddish Streaks
Material Location:	Women's Bathroom
ACM Y/N:	No

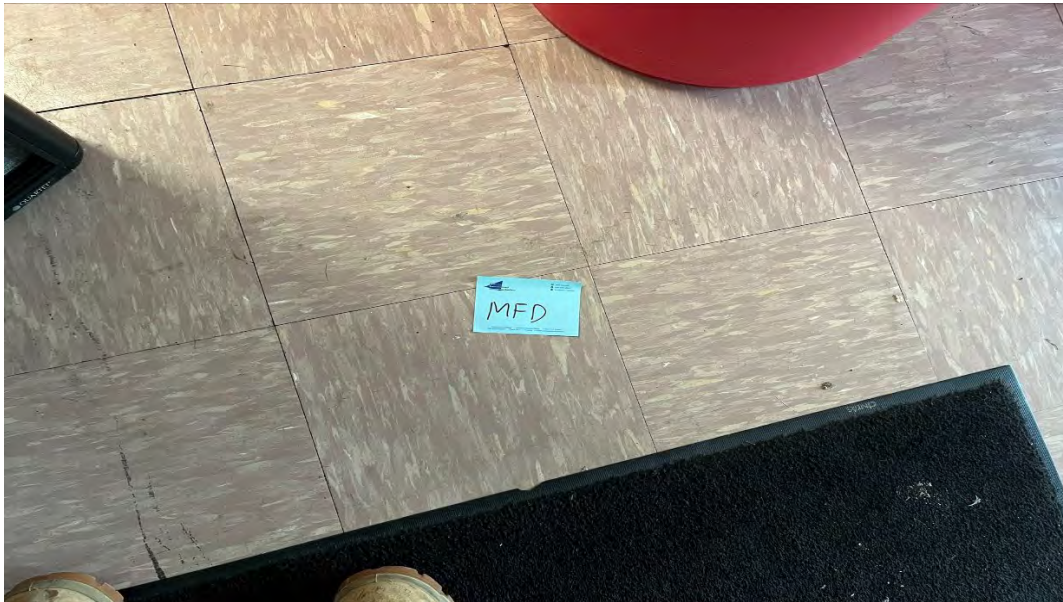
Homogeneous Area:	MFD
Material Description:	12x12 Floor Tile/Mastic - Pinkish Color w/ White Streaks
Material Location:	Foyer, Hallway of Second Floor, Storage Room 3, Break Room,
ACM Y/N:	No

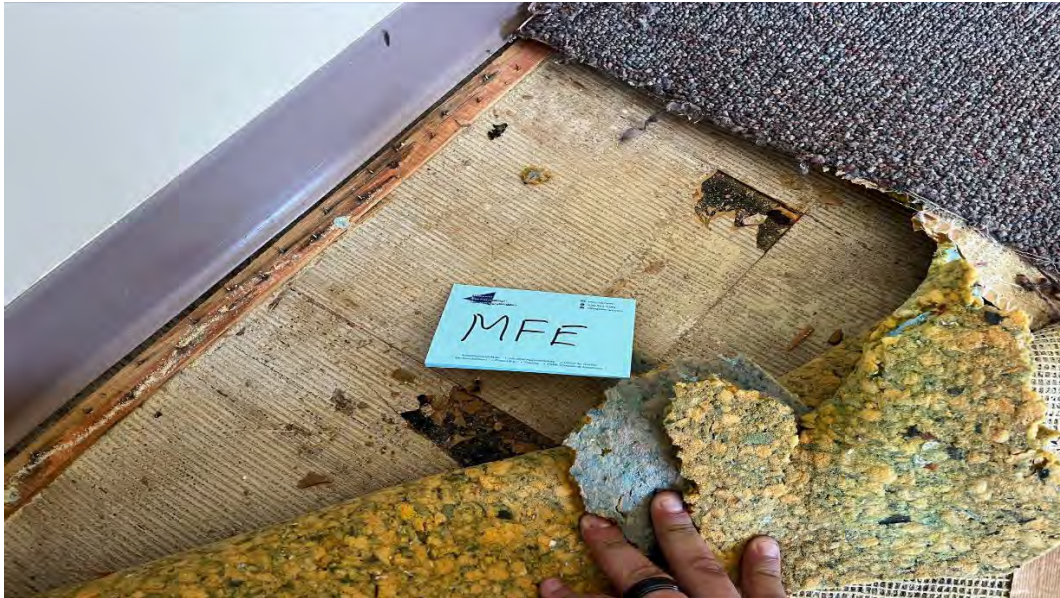
Homogeneous Area:	MFE
Material Description:	12x12 Floor Tile/Mastic - Brown
Material Location:	Under Carpet of the Community Room
ACM Y/N:	Yes

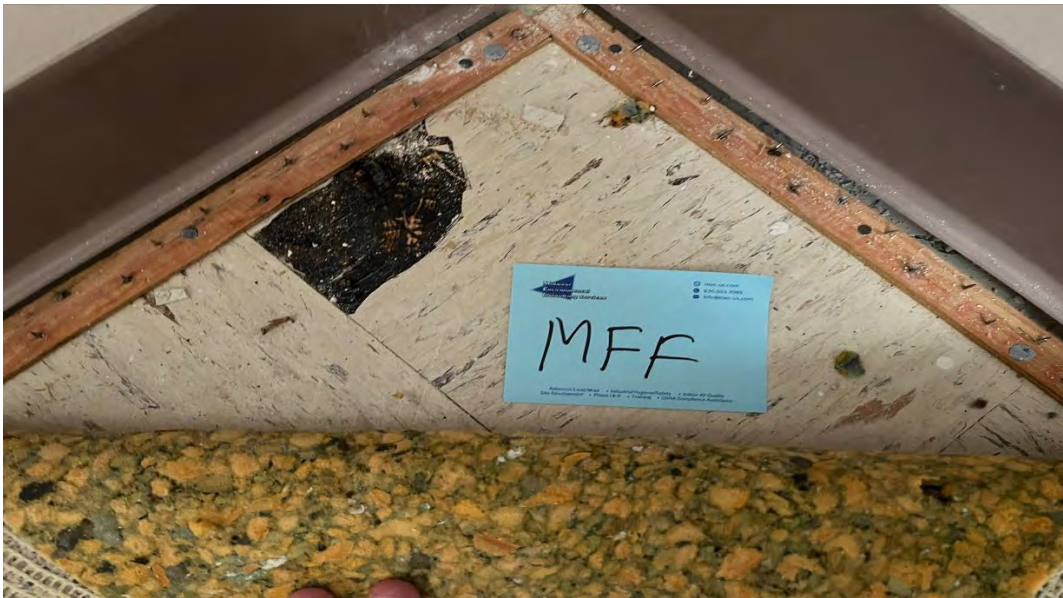
Homogeneous Area:	MFF
Material Description:	12x12 Floor Tile/Mastic - White w/ Black Streaks
Material Location:	Suite 201
ACM Y/N:	Yes

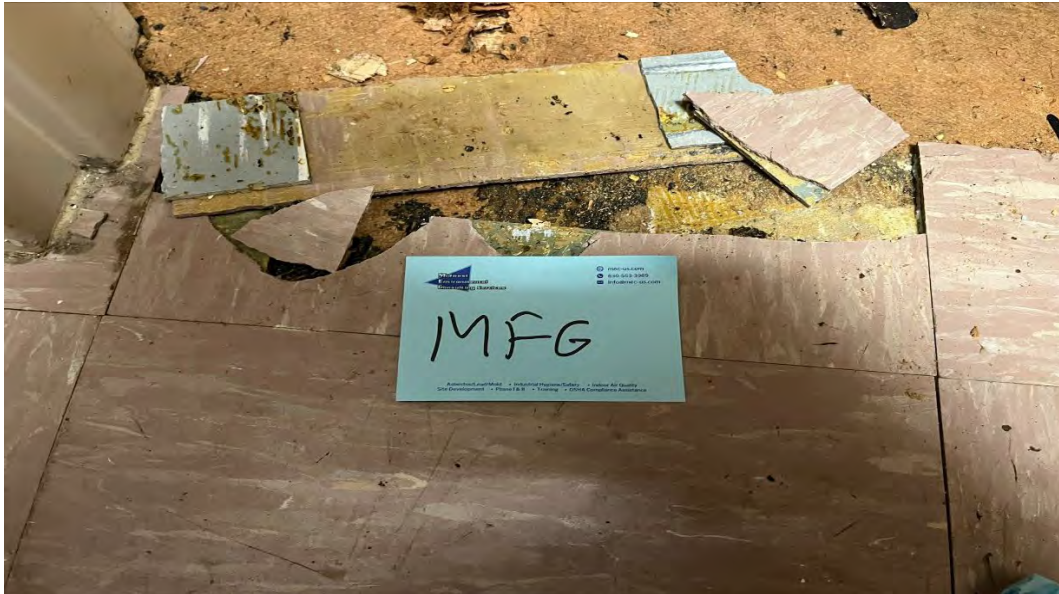
Homogeneous Area:	MFG
Material Description:	12x12 Floor Tile/Mastic - Gray w/ White Streaks
Material Location:	Under MFG on 2nd Floor
ACM Y/N:	Yes

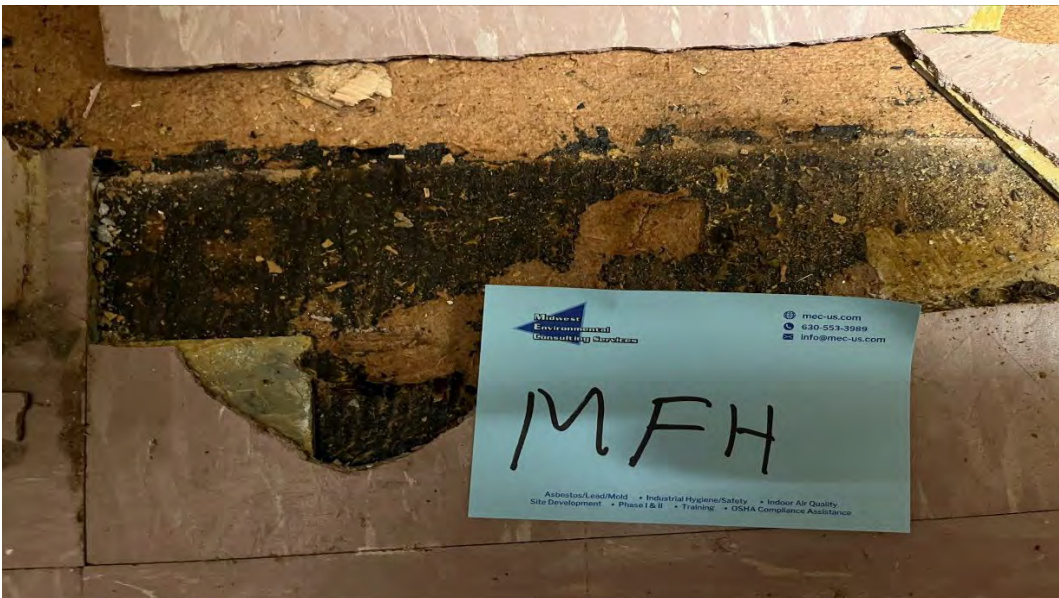
Homogeneous Area:	MFH
Material Description:	Fiberboard Floor/Mastic
Material Location:	Under MFG on 2nd Floor
ACM Y/N:	Yes

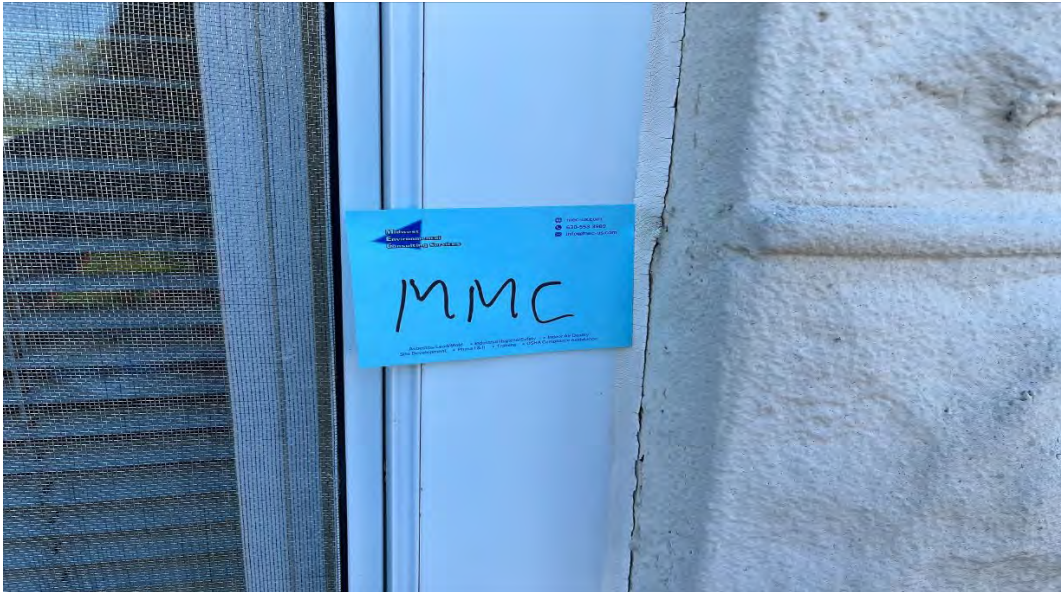
Homogeneous Area:	MMC
Material Description:	Exterior Window Caulk
Material Location:	Exterior Windows
ACM Y/N:	No

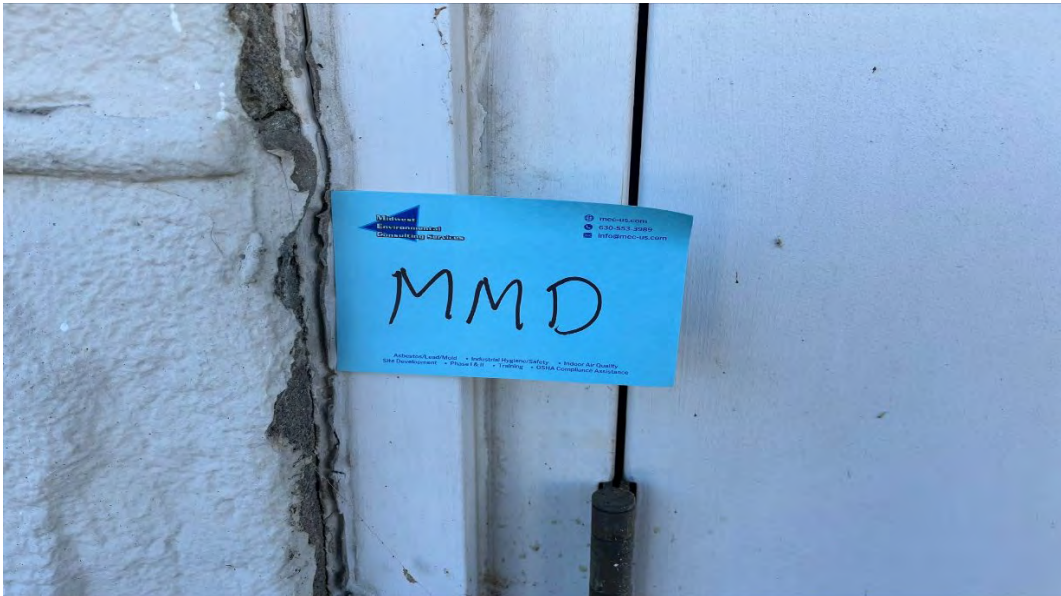
Homogeneous Area:	MMD
Material Description:	Exterior Door Caulk
Material Location:	Exterior Doors
ACM Y/N:	No
