Limited Building Assessment Final Report

- W01 - Citizen Activities Center
- W02 - Village Hall
- W03 - Community Development
- W04 - Police Department

September 2021
Kluber Job #21-434-1359

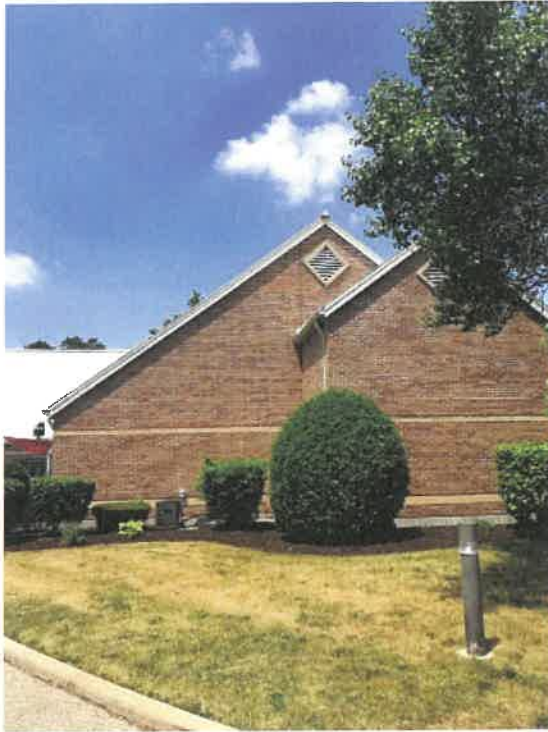
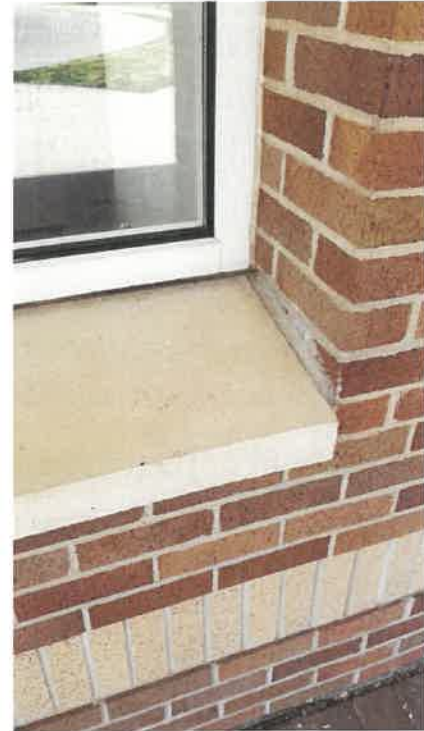
- The Police Department Building (W04): The exterior wall surfaces of the Police Station consist of clay unit masonry (brick) veneer and limestone accent banding, load bearing cavity wall with 2 inch rigid cavity insulation and 8 inch concrete masonry unit (CMU) backup. Interior side of exterior walls are furred with wood furring strips and topped with gypsum board. The R-Value of the exterior walls is approximately R-12. The exterior masonry walls surfaces are in good condition with only minor sealant joint repairs needed

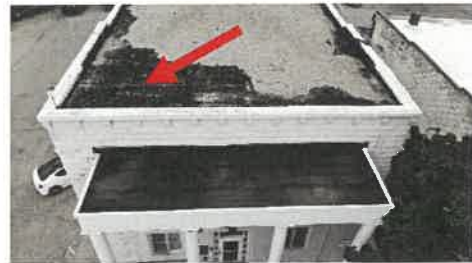
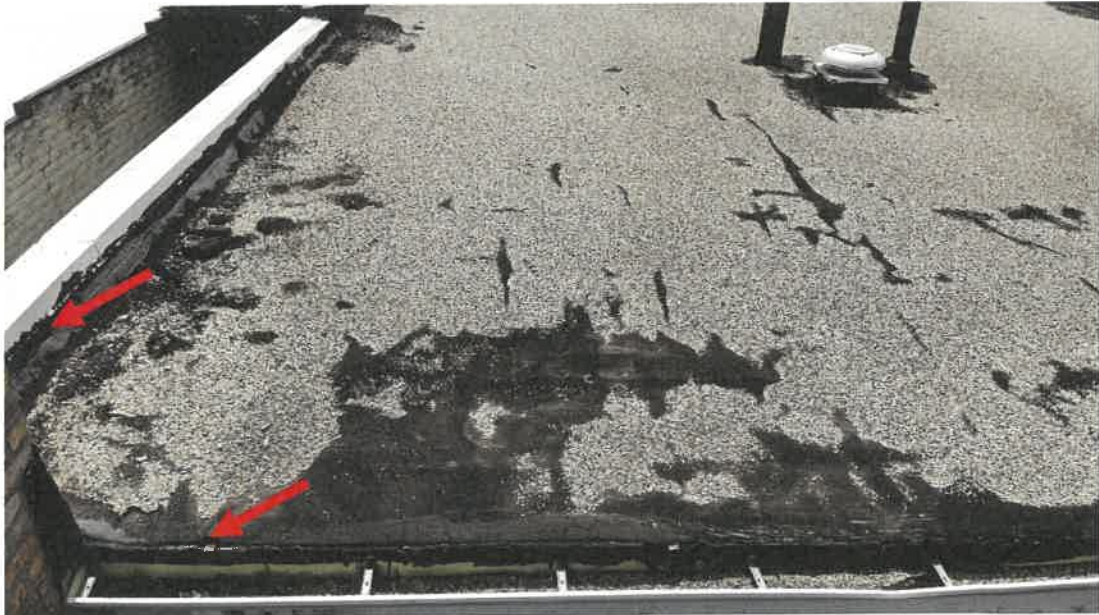
- The roof surfaces are built-up type with tar and gravel at the upper two story portion of the building (right photo). Some gravel surfaces have washed down the slope of the roof. The upper roof appears to be reaching the end of its useful life.
- The roof over the front porch is a built-up roof system with no granular surfacing. This roof surface has some localized membrane deterioration and cracking noted. This roof does not have any roof drains and downspouts, so water is draining off the west end and has damaged the soffit below. Drainage scuppers and downspouts should be added at each end of this roof area when the roof membrane is replaced.
- The upper roof is showing sign of failure at the counterflashings, and gutter locations as shown below.

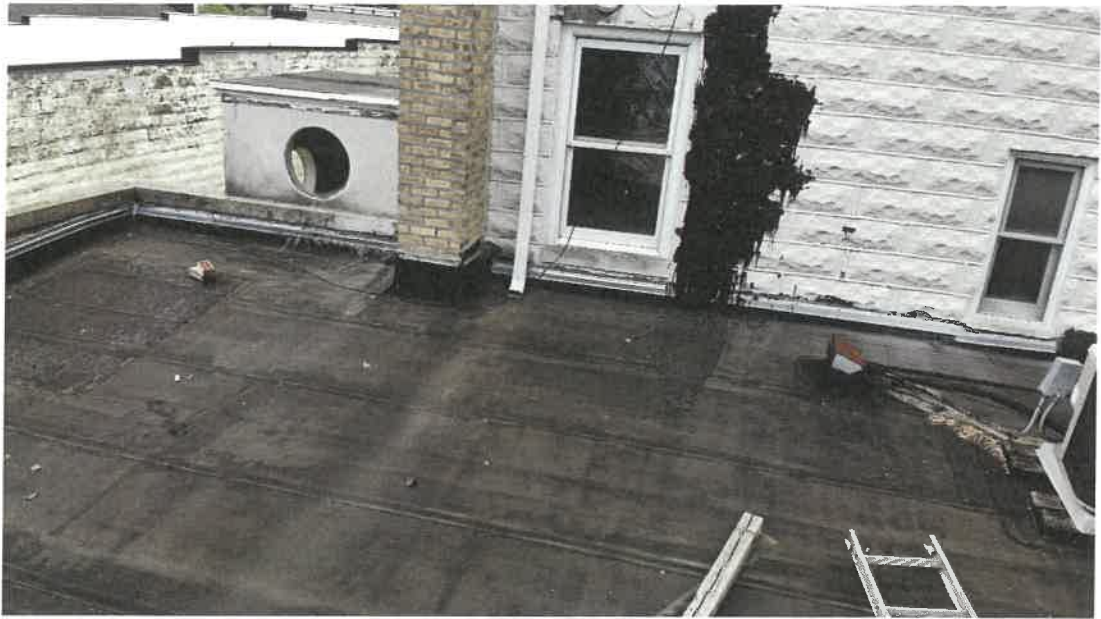
- This is a view of the north single story roof area that is also a built-up system without the granular surfacing. This roof surface is beyond its useful life and is cracking in multiple locations.

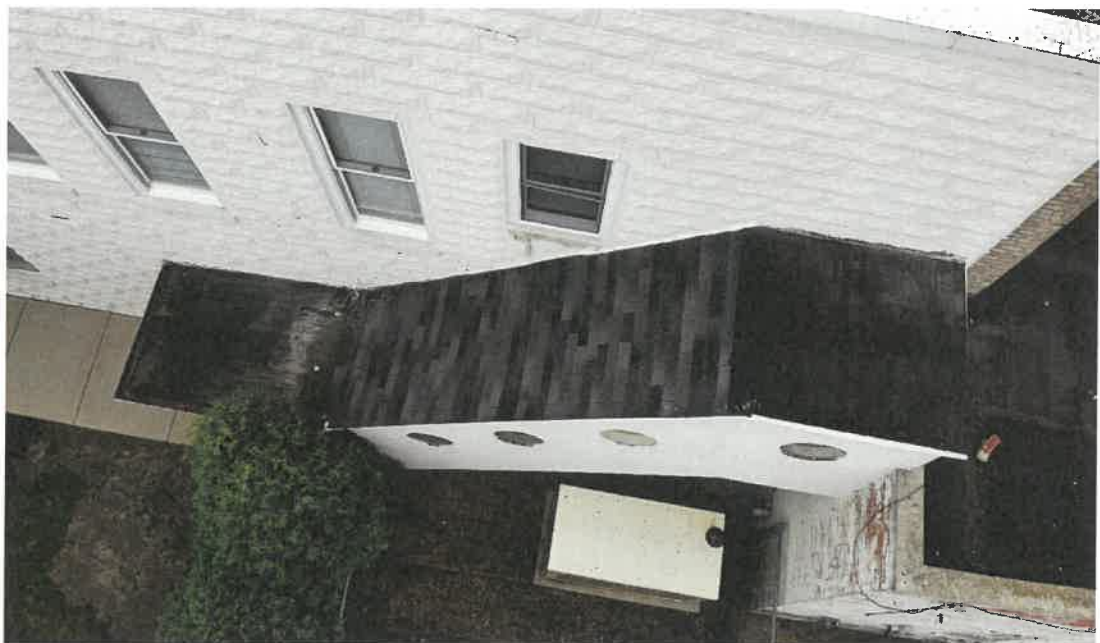
- This is a view of the east exit stairway roof that is a combination of asphalt shingles and built up roof systems. The built up roof at the grade level vestibule and at the top of the staircase is in very poor condition.

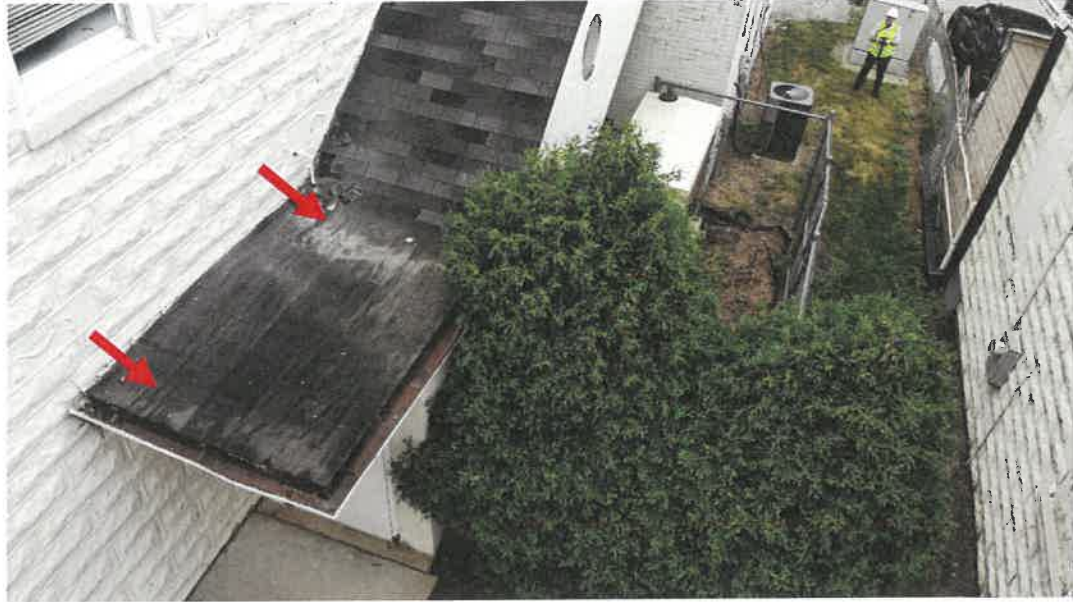
- This is a closer look at the lower roof area at the east exit stairway. Arrow locations are roof membrane areas that have failed or are beginning to fail.

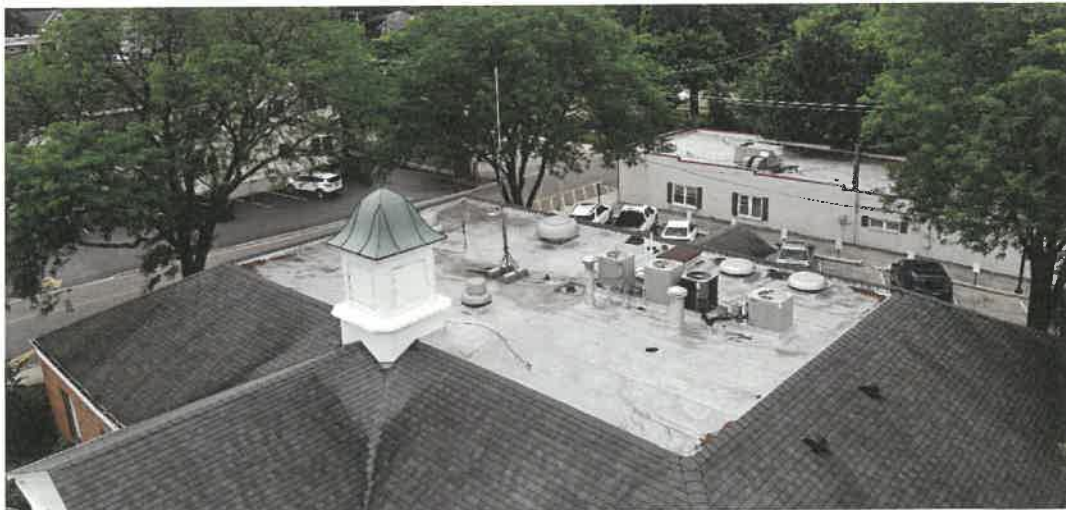
- The Village Hall building is a combination of built-up roofing with an aluminized coating at the upper flat roof area and architectural shingles systems on the sloped roof areas. The architectural shingles appear to have localized areas of algae growth noted by the dark stains. The asphalt shingles are estimated to have 7-10 years of useful life remaining. The flat roof has been coated with an aluminized coating to prolong the life of the roof membrane. Some roof areas are now showing sign of cracking and a few areas of the roof did not have proper pitch to shed water to roof drains creating ponding sections. The flat roof area is recommended for replacement within 5-7 years. The upper roof cupola is clad with copper standing seam roofing in good condition. The cupola paint is failing and needs to be repainted.

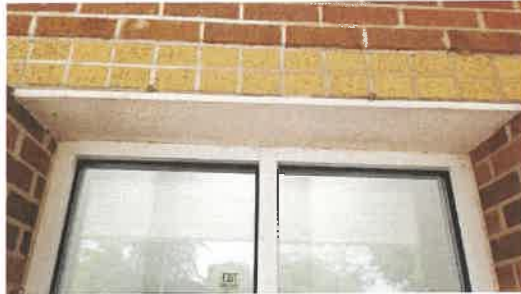
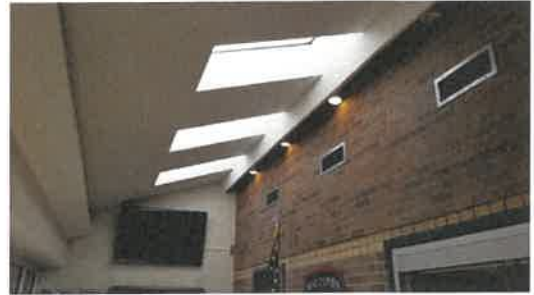
- The exterior window systems consist of aluminum storefront or aluminum clad window units with portions being operable at the Police Station. Skylights also exist at the Police Station. No observable water leaks were evident upon arrival. Some localized exterior sealant joint failure was noted.

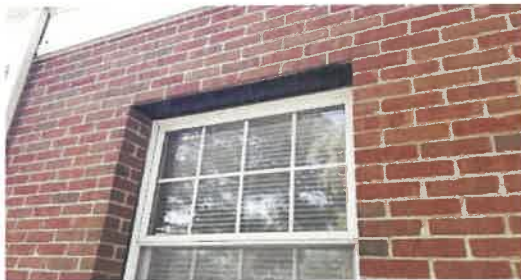
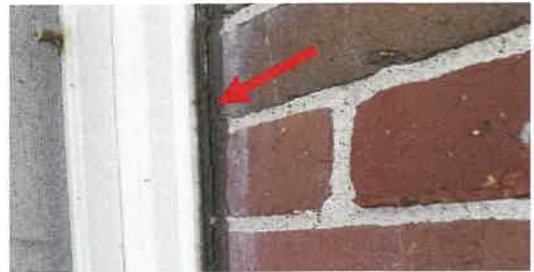
- The windows at the Village Hall are metal clad, double hung wood type. Exterior sealant joints are failing and need maintenance repair.

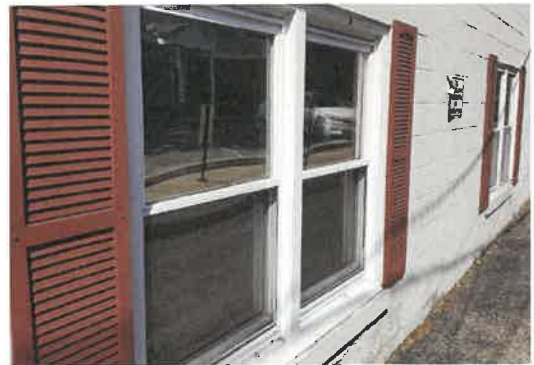
- The windows at the Community Development building (right) are metal clad double hung wood operable units at office and meeting room areas and fixed units at the main lobby area. The windows are generally in acceptable condition with only minor sealant joint failure that should be repaired.

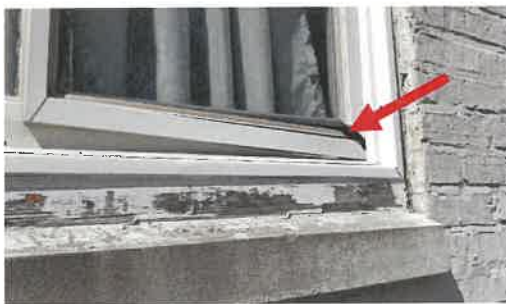
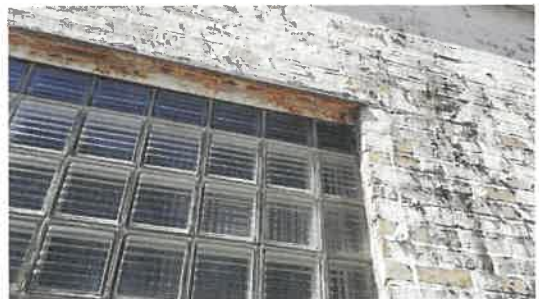
- The windows at the Citizens Activity Center (below) are combinations of metal clad casement, double hung and fixed aluminum storefront units with select areas infilled with glass block. Several metal clad windows are broken and beyond repair and need to be replaced.

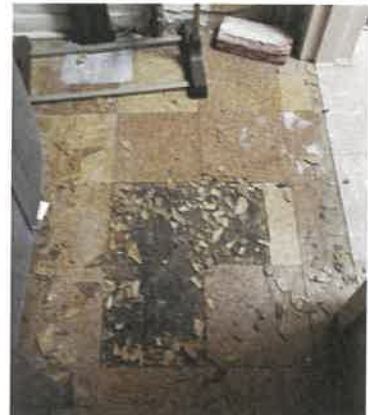
- The primary interior flooring surfaces consists of VCT floor tile, VAT floor tile, carpet, and sealed concrete at the north building addition.
- The carpeted surfaces for a majority of this building require replacement in the next 2 - 3 years.
- The vinyl composition floor tile products appear to be in relatively good condition in the recently renovated toilet rooms but also require periodic stripping, waxing, and buffing to maintain its current appearance.
- Vinyl asbestos tile was found in the second floor mechanical room and will require abatement. The tile is loose and friable. See photo at the right. This room should be locked free of public access until this tile can be removed and legally disposed of.

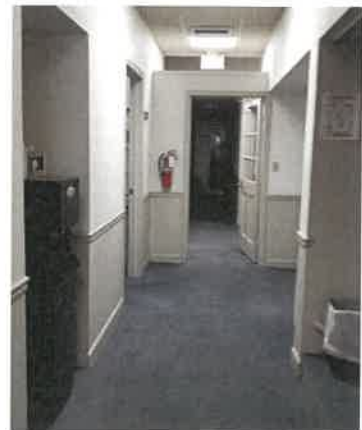
- The primary interior flooring surfaces consists of VCT floor tile, carpet, and sealed concrete at the basement areas.
- The carpeted surfaces for a majority of this building require replacement in the next 3-5 years as it is showing its age and is worn in some areas. See photo at right.
- The vinyl composition floor tile products appear to be in relatively good condition but also require periodic stripping, waxing, and buffing to maintain its current appearance.
- The staircase to the basement is covered with rubber stair treads with non-slip nosings in good condition.
- The basement floor area is sealed concrete in good condition.
- Sheet vinyl flooring is in good condition however it is discoloring. Sheet vinyl flooring shall be replaced when future renovations occur.

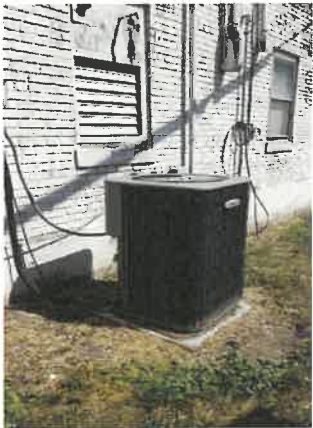
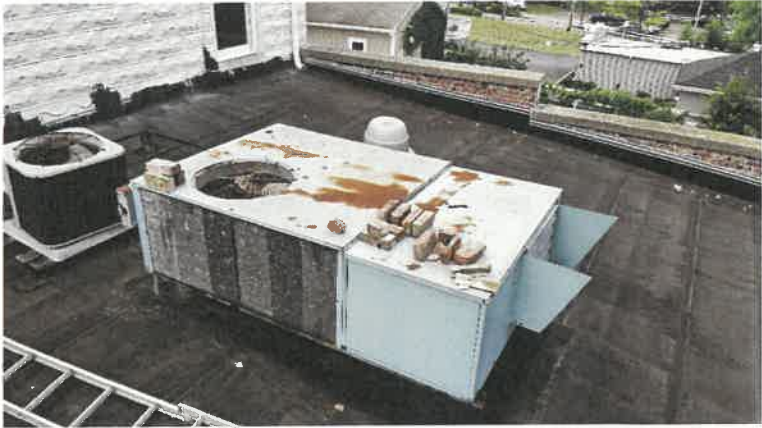
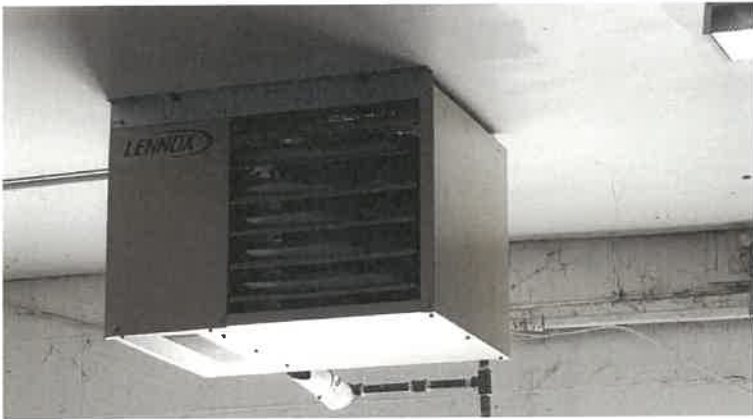
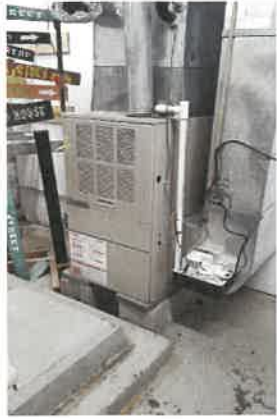
- Mechanical Systems - The south building area building is heated, cooled, and ventilated with furnaces and remote condensing units. The furnace and condensing unit servicing the 1st floor office area is newer and in operable condition. One condensing unit is on the North single story roof area servicing the 2nd floor and is an older unit nearing the end of its service life. The second floor furnace is older and appears to be at its median service life however is still operational. One condensing unit is on the ground on the east side of the building servicing the 1st floor offices. The north, one story building addition was formerly heated and cooled with a Roof Top unit that appears to have been abandoned in place. See right photo below. Ductwork for the RTU inside the building is also partially disconnected from this unit. The north addition also has a newer natural gas, ceiling mounted unit heater to heat the space in the winter. Bottom left photo. The building has zone thermostats.

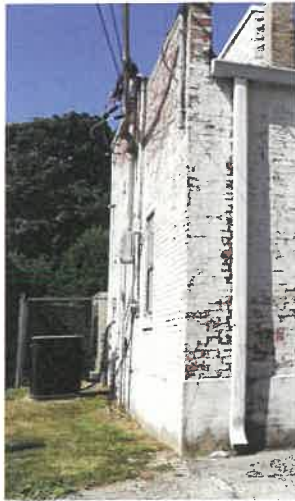
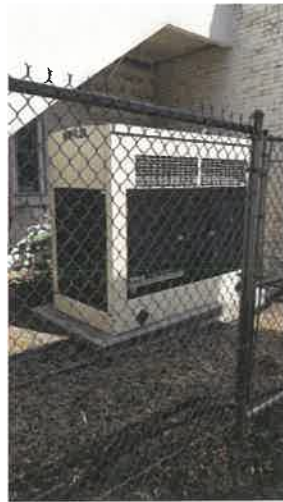
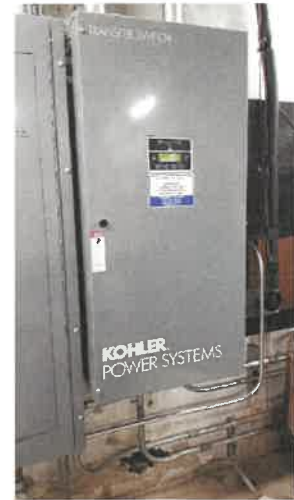
- The building is fed underground from an overhead electrical service at the northeast corner of the building. See photo bottom left. The main service is rated at 120/208V., 3PH., 4W., 200A. The original building electrical service appears to have been abandoned and decommissioned in place. The Lighting, Power and HVAC distribution system is composed of 120/208V branch circuit panelboards located throughout the facility. The building has a natural gas, 30KW Kohler exterior mounted generator located on the east façade of the building. A newer transfer switch has also been installed for the generator. See photo bottom right.

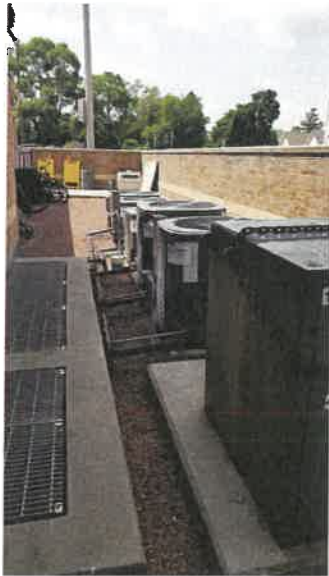
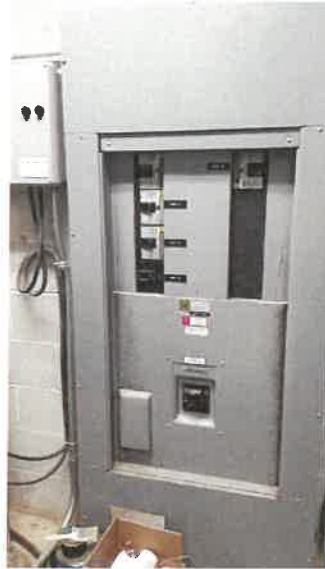
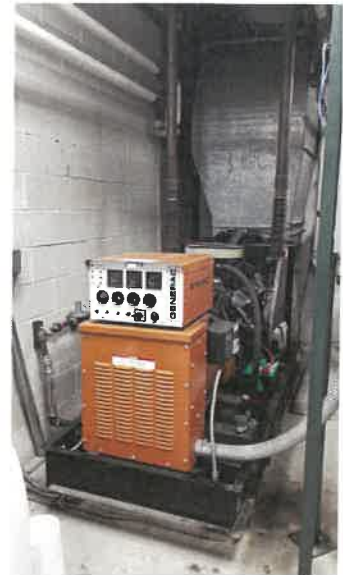
- The building is fed underground from a pad mounted exterior transformer located at the west end of the building. The main service is rated at 120/208V., 3PH., 4W., 600A. The Lighting, Power and HVAC distribution system is composed of 120/208V branch circuit panelboards located throughout the facility. The building has a natural gas, 30KW interior generator located in the northwest basement mechanical room and provides power for emergency loads and localized power and lighting circuits.
