To: Dan Quick, Village Administrator

Date: August 11, 2010

**Public Works, Building and Zoning, and Environmental Quality Department
Administrative Report for July 29th through August 11th, 2010**

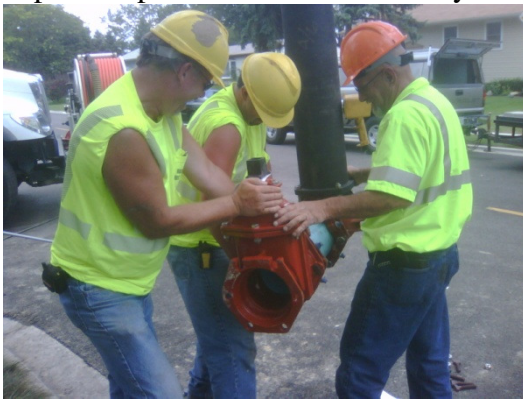
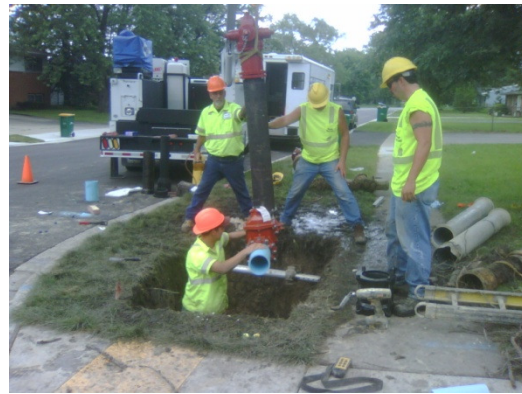
Hydrant Replacement

On July 29th, an old fire hydrant on Larkdale Row at Walnut Road was excavated and replaced. During the leak survey completed late this past winter, the hydrant was found to have a small leak, but it could not be repaired since the shut off valve to the hydrant did not close down and an attempt to stop the leak rendered the hydrant inoperable.
