Limited Building Assessment Final Report

- W01 - Citizen Activities Center
- W02 - Village Hall
- W03 - Community Development
- W04 - Police Department

September 2021
Kluber Job #21-434-1359

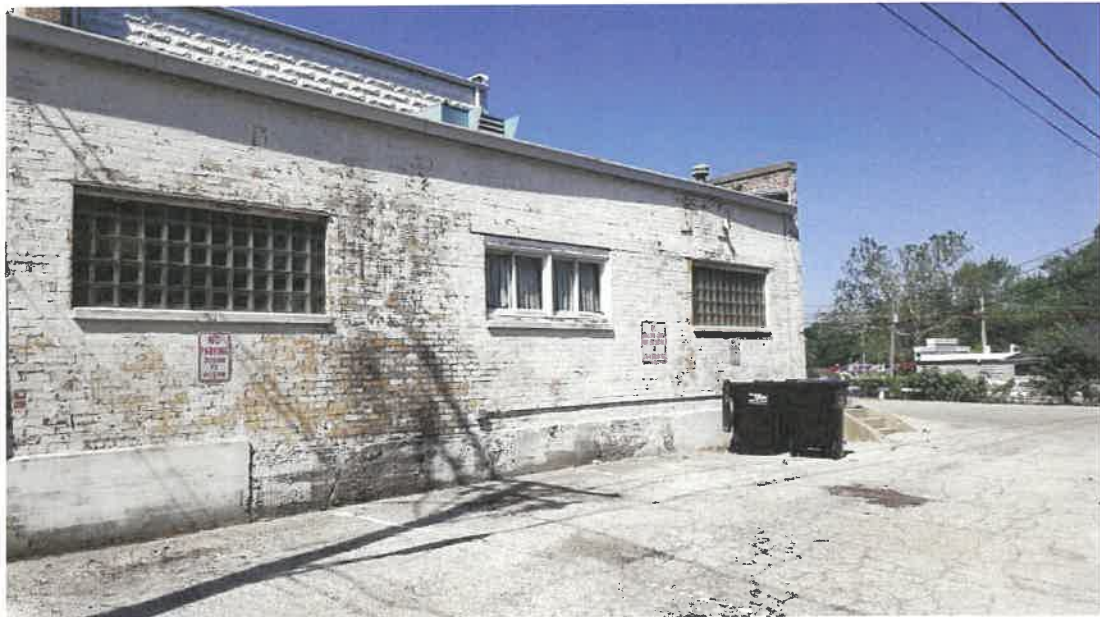
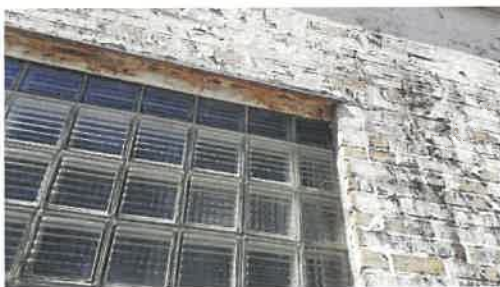
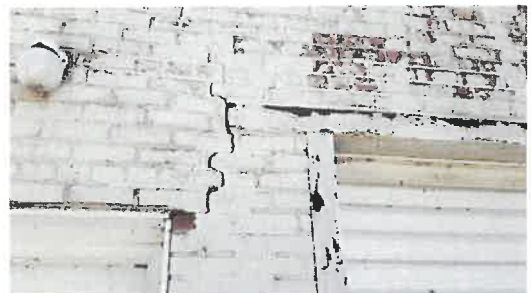
- The exterior envelopes for the majority of the Village's buildings consist of either load bearing masonry or masonry veneer and wood frame construction or concrete block backup construction.
- The Citizen Activity Center Building (W01): The exterior wall surfaces consist of load bearing stone masonry at the original two story structure that has been painted. The north one story (former police department) addition is load bearing brick and block masonry that has also been painted. Both building façade areas have peeling paint from water damage, need significant tuckpointing at the north addition and select location of the original structure. Some masonry settlement cracks were also observed in both masonry and concrete foundation walls.
